[Docket No. 2002–SW–42–AD; Amendment 39–12936; AD 2002–17–51]

Airworthiness Directives; Agusta S.p.A. Model A109E Helicopters

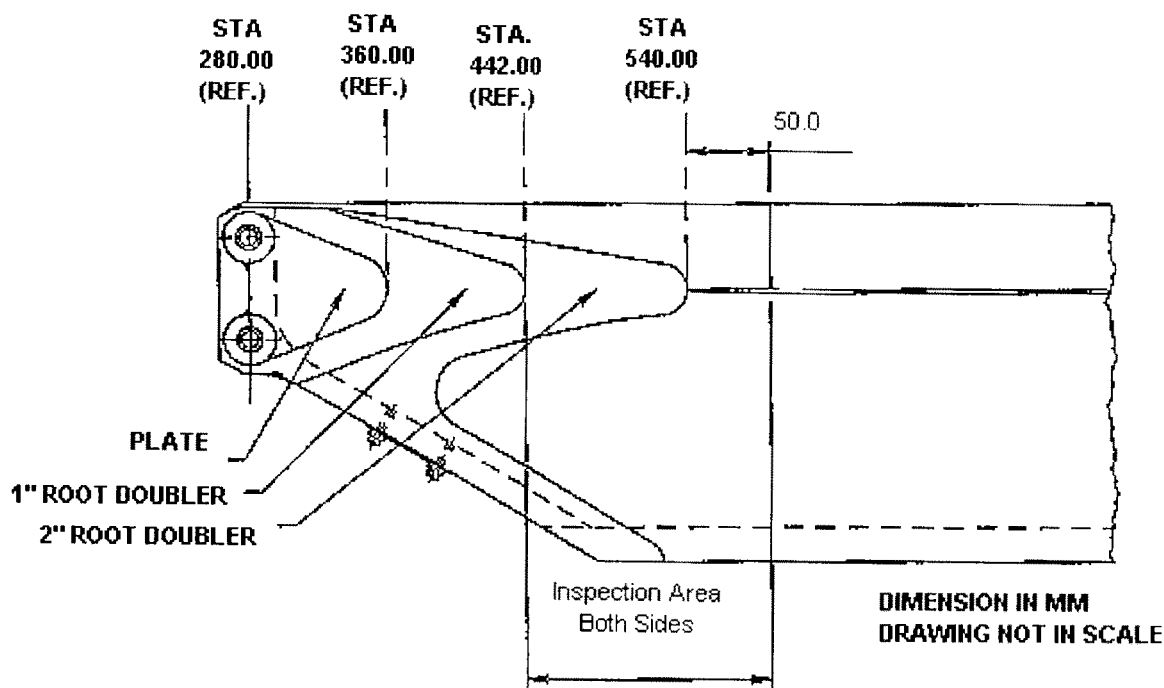
FIGURE 1

(b) Before each start of the helicopter engines, visually check both sides of each tail rotor blade for a crack in the area depicted in Figure 1 of this AD. And owner/operator (pilot) holding at least a private pilot certificate may perform this visual check and must enter compliance with this paragraph into the aircraft maintenance records in accordance with 14 CFR 43.11 and 91.417(d)(2)(v). See Figure 1:

Part Number 109-8132-01-111 Tail Rotor Blade

Note 2: Paint irregularities on the tail rotor blade may be due to a crack.

(c) Within 25 hours time-in-service (TIS), and thereafter at intervals not to exceed 25 hours TIS, and anytime there is an increase in vibration levels, using a 5x or higher magnifying glass, visually inspect each tail rotor blade for a crack before further flight in accordance with the Compliance Instructions, Part III, paragraphs 1. through

5., of the BT. Reporting to Agusta Service Engineering is not required. If you are unable to determine by the visual inspection whether there is a crack, dye penetrant inspect the tail rotor blade for a crack in accordance with the Compliance Instructions, Part III, paragraph 6., of the BT.

(d) Replace any cracked tail rotor blade with an airworthy blade before further flight.
