[Docket No. FAA-2015-3989; Directorate Identifier 2014-NM-250-AD; Amendment 39-18600; AD 2016-16-02]

Airworthiness Directives; Airbus Airplanes

SUMMARY: We are adopting a new airworthiness directive (AD) for all Airbus Model A318, A319, A320, and A321 series airplanes. This AD was prompted by reports of premature aging of certain passenger chemical oxygen generators that resulted in the generators failing to activate. This AD requires an inspection to determine if certain passenger chemical oxygen generators are installed and replacement of affected passenger chemical oxygen generators. We are issuing this AD to prevent failure of the passenger chemical oxygen generator to activate and consequently not deliver oxygen during an emergency, possibly resulting in injury to the airplane occupants.

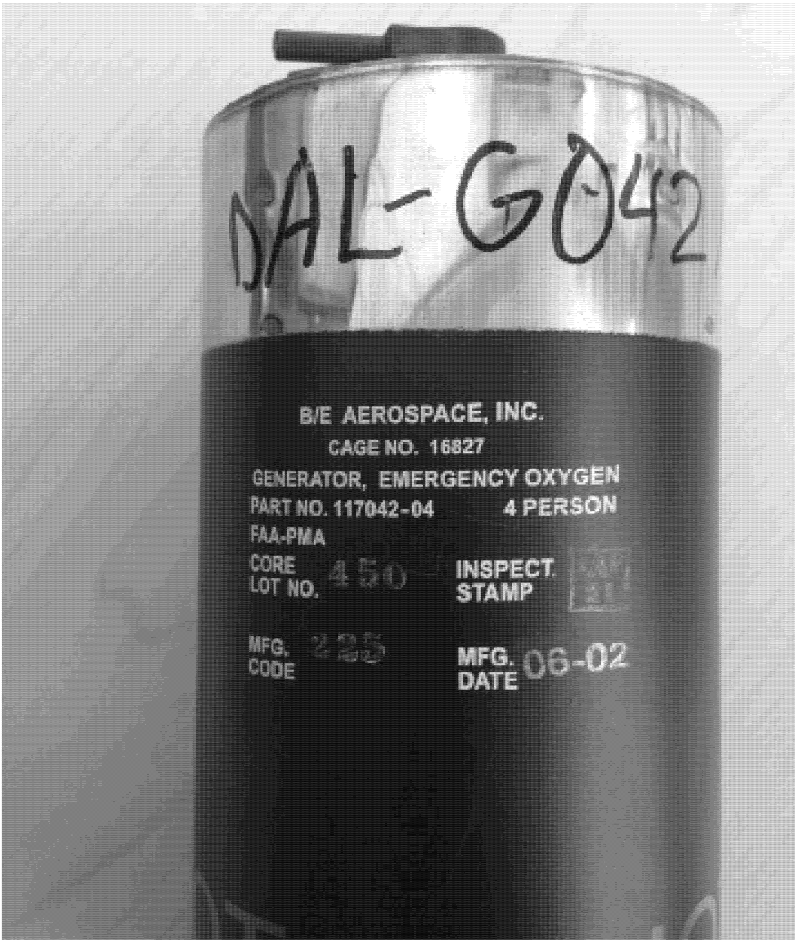
Figure 2 to Paragraph (g) of this AD - MFG.DATE (06-02 = June 2002)
Example
