[Docket No. 2004–SW–12–AD; Amendment 39–13884; AD 2004–24–08]

Airworthiness Directives; Bell Helicopter Textron Canada Model 206A, B, L, L–1, L–3, and L–4 Helicopters

ACTION: Final rule; request for comments.

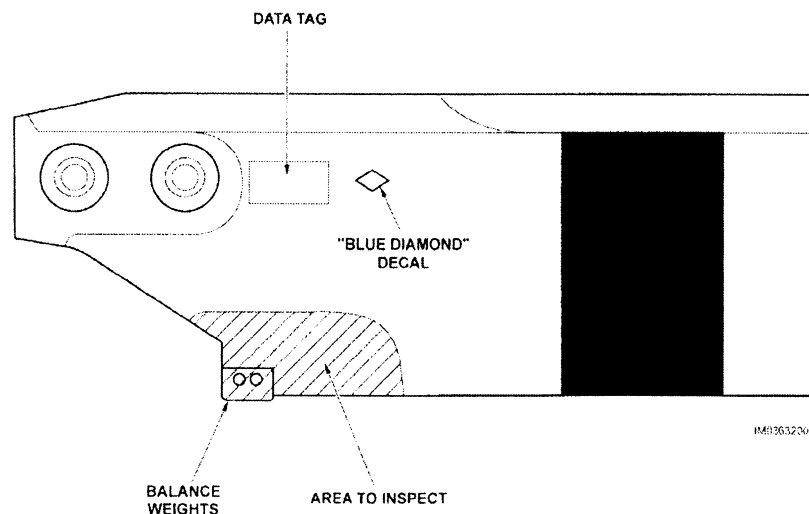
Figure 1. Tail rotor blade inspection.

replacing each blade with an airworthy blade if a deformation, a crack, or a bent or deformed weight is found. This amendment is prompted by three reports of skin cracks originating near the blade trailing edge balance weight. In two reports, a loss of the weight and a strip of material along the trailing edge led to an imbalance and fracture of three of the four tail rotor gearbox attachment bolts. In one of these incidents the gearbox shifted resulting in failure of the drive shaft and loss of yaw control. This condition, if not detected, could result in blade failure and subsequent loss of control of the helicopter.

crack, and a bent or deformed weight in the area shown in Figure 1 of this AD.

Note 1: Paint irregularities on the blade may indicate a crack.

(1) At intervals not to exceed 12 hours time-in-service (TIS), using a 10X or higher magnifying glass, inspect both sides of each blade for a deformation, a crack, and a bent or deformed weight in the area shown in Figure 1 of this AD, or

(2) Inspect and check both sides of each blade for a deformation, a crack, and a bent or deformed weight in the area shown in Figure 1 of this AD as follows:

(c) Before further flight, replace any blade that has a deformation, a crack, or a bent or deformed weight with an airworthy blade.
