[Docket No. 2000–SW–60–AD]

#### Airworthiness Directives; Bell Helicopter Textron, Inc., Model 412 Helicopters

**ACTION:** Notice of proposed rulemaking (NPRM).

**BELL HELICOPTER TEXTRON, INC.:** Docket No. 2000-SW-60-AD.

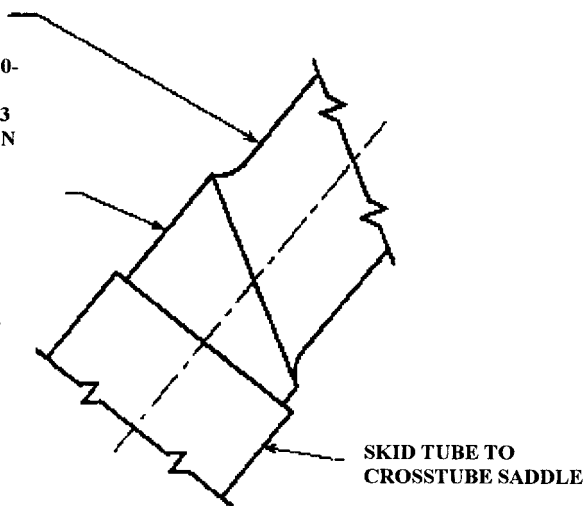
FIGURE 1

THE FACTORY HAS INK  
STAMPED THE SUBASSEMBLY  
AND SYNTHETIC P/N 412-050-  
044-101, -101A, OR -103 IN THIS  
GENERAL AREA.

CROSSTUBE ASSEMBLY P/N 412-050-  
045-107 HAS THE NEXT LOWER  
(SUBASSEMBLY) P/N 412-050-044-103  
VIBRO-ETCHED IN THIS LOCATION  
FROM THE FACTORY. THE S/N IS  
POSITIONED UNDER THE P/N.

VIBRO-ETCH 412-050-011-107 FM  
AND A COMPANY CONTROLLED  
S/N IN THIS AREA AS REQUIRED  
TO TRACK REMAINING HIGH AFT  
CROSSTUBE LIFE. VIBRO-  
ETCHING DEPTH SHALL NOT  
EXCEED 0.005 INCH.

HIGH AFT CROSSTUBE

(3) Vibro-etch the P/N on the crosstube assembly adjacent to the skid tube saddle in accordance with Figure 1 for any crosstube assembly not displaying a visible P/N. Identify the crosstube assembly as P/N 412-050-011-107 FM.

(4) Vibro-etch a serial number (S/N) on the crosstube assembly below the P/N in accordance with Figure 1. The S/N must be unique for each crosstube assembly.
