[Docket No. 2004-NE-07-AD; Amendment 39-13579; AD 2004-08-10]

Airworthiness Directives; Engine Components Incorporated (ECi) Reciprocating Engine Cylinders

2004–08–10 Engine Components Incorporated (ECi): Amendment 39– 13579. Docket No. 2004–NE–07–AD.

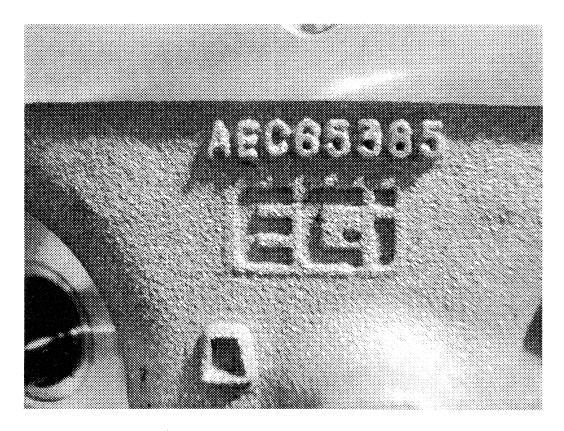
(iii) If the casting has AEC65385, and an "O" under the ECi logo, the cylinder is P/N AEC631397. See Figure 3.

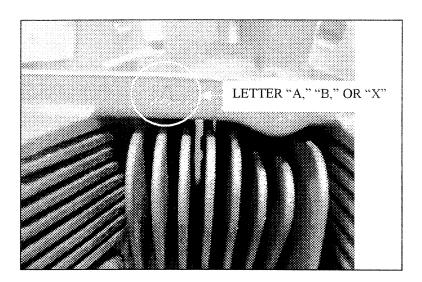
(ii) If there is a letter "A," "B," or "X" stamped on the flange of the rocker box, no further action is required. See Figure 4.

(iii) If there is no letter "A," "B," or "X" stamped on the flange of the rocker box, replace the cylinder before further flight.
