[Docket No. 99-SW-34-AD; Amendment 39-12452; AD 2000-10-08 R1]

Airworthiness Directives; Eurocopter France Model SA-365N1, AS-365N2, and SA-366G1 Helicopters

ACTION: Final rule.

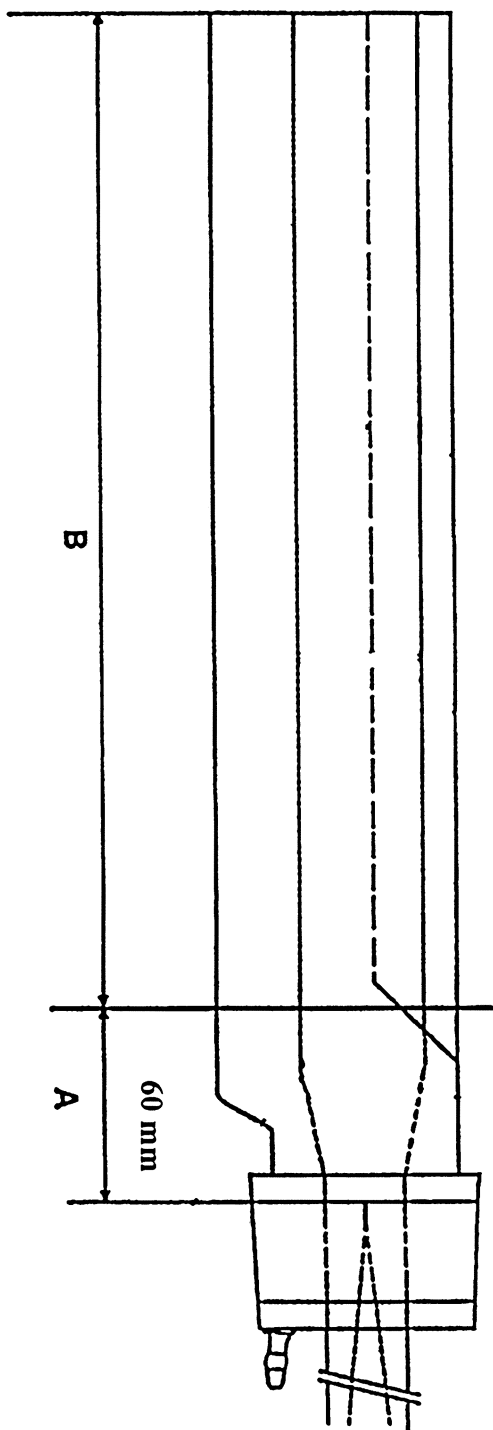
FIGURE 1

(a) Within 10 hours time-in-service (TIS) and thereafter before the first flight of each day, visually check each blade (see Figure 1) for a crack, blister, or wrinkling. An owner/operator (pilot), holding at least a private pilot certificate, may perform the visual check and must enter compliance into the aircraft maintenance records in accordance with 14 CFR sections 43.11 and 91.417(a)(2)(v).

(b) If a crack, blister, or wrinkling is found as a result of the visual check, accomplish the following before further flight (see Figure 1):

(1) *Zone A:* If a blister is detected on the blade suction face, conduct a tapping test inspection on the whole blade for bonding separation.

(ii) For blades, P/N 365A12-0020-02, and -03, if bonding separation exceeds 900 mm² in a 30 × 30 mm square or if there is a crack, replace the blade with an airworthy blade before further flight.

(2) *Zone B:* If a crack, wrinkling, or a blister is found, replace the blade with an airworthy blade before further flight.

(i) For blades, P/N 365A33-2131—all dash numbers, 365A12-0010—all dash numbers, and 365A12-0020-00, and -01, if bonding separation or a crack is found, replace the blade with an airworthy blade before further flight.

(c) Within 10 hours TIS, conduct a tapping test inspection on each blade. If there is bonding separation that exceeds the criteria in paragraph b(1) of this AD, replace the blade with an airworthy blade before further flight.
