[Docket No. 2002-SW-38-AD; Amendment 39-12935; AD 2002-22-10]

Airworthiness Directives; Bell Helicopter Textron Canada Limited Model 407 Helicopters

ACTION: Final rule; request for comments.

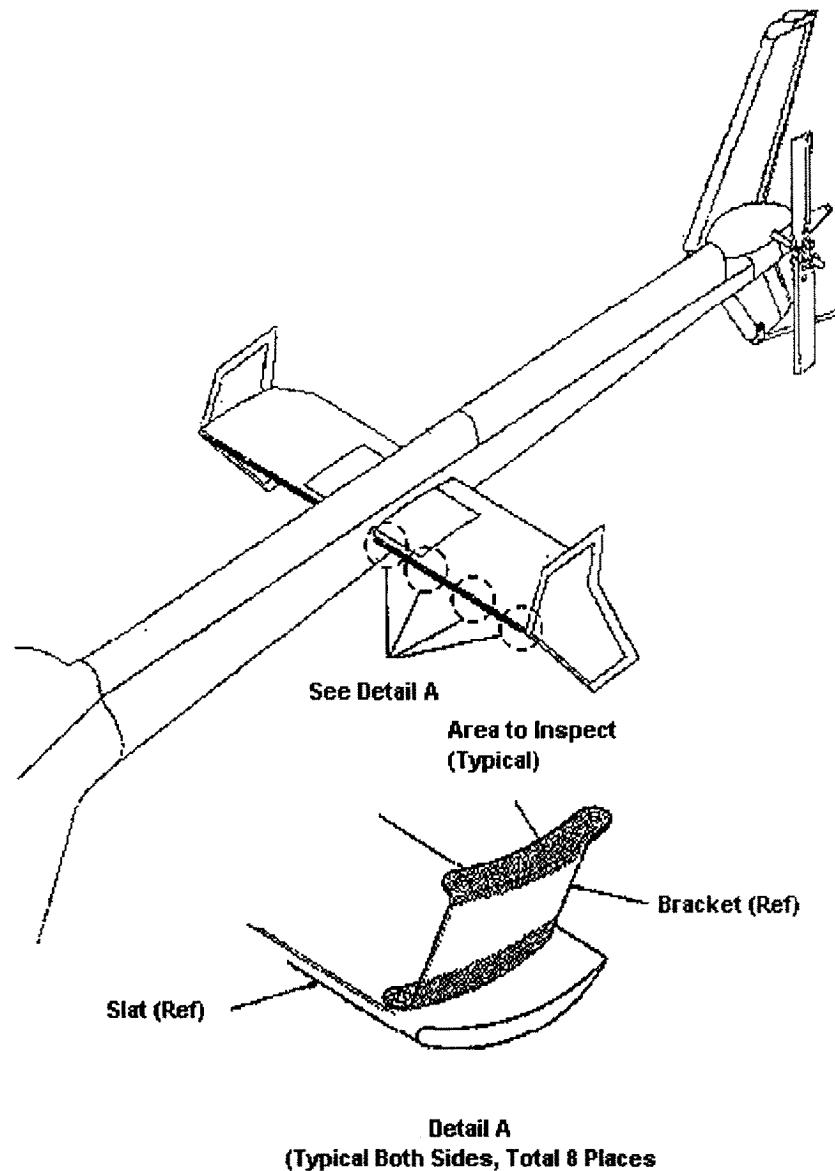
Since issuing that AD and since installing the newly designed slat assembly, part number (P/N) 407-023-001-101 on affected helicopters, two additional cracked slat brackets have been reported. These occurrences are attributed to a design flaw and improper installation of the slat assembly.

(1) Within 10 hours time-in-service (TIS) and thereafter before the first flight of each day, check each slat for a crack at the radius

of each bracket, part numbers (P/N) 206-023-119-109, -110 or 407-023-801-127, -128, or

407-023-001-119, -120, or -121, as shown in Figure 1 of this AD:

Figure 1. Pre-Flight check of brackets, horizontal stabilizer slats.

(3) If a crack is found, before further flight, replace slat assembly, P/N 407-023-002-117 or 407-023-001-101, with an airworthy, segmented slat assembly, P/N 407-023-001-103.

(1) For helicopters, S/N 53000 through 53498, replace slat assembly, P/N 407-023-002-117 and 407-023-001-101, with an airworthy, segmented slat assembly, P/N 407-023-001-103, in accordance with the Accomplishment Instructions, Part II, Bell Helicopter Textron Alert Service Bulletin 407-02-52, dated March 20, 2002 (ASB).
