Airworthiness Directives; Eurocopter Deutschland GmbH Helicopters

2012–13–11 Eurocopter Deutschland GmbH

Helicopters: Amendment 39–17113;
Docket No. FAA–2012–0704; Directorate
Identifier 2012–SW–040–AD.

Joint Aircraft Service Component (JASC)
Code: 6420: Tail Rotor Head.

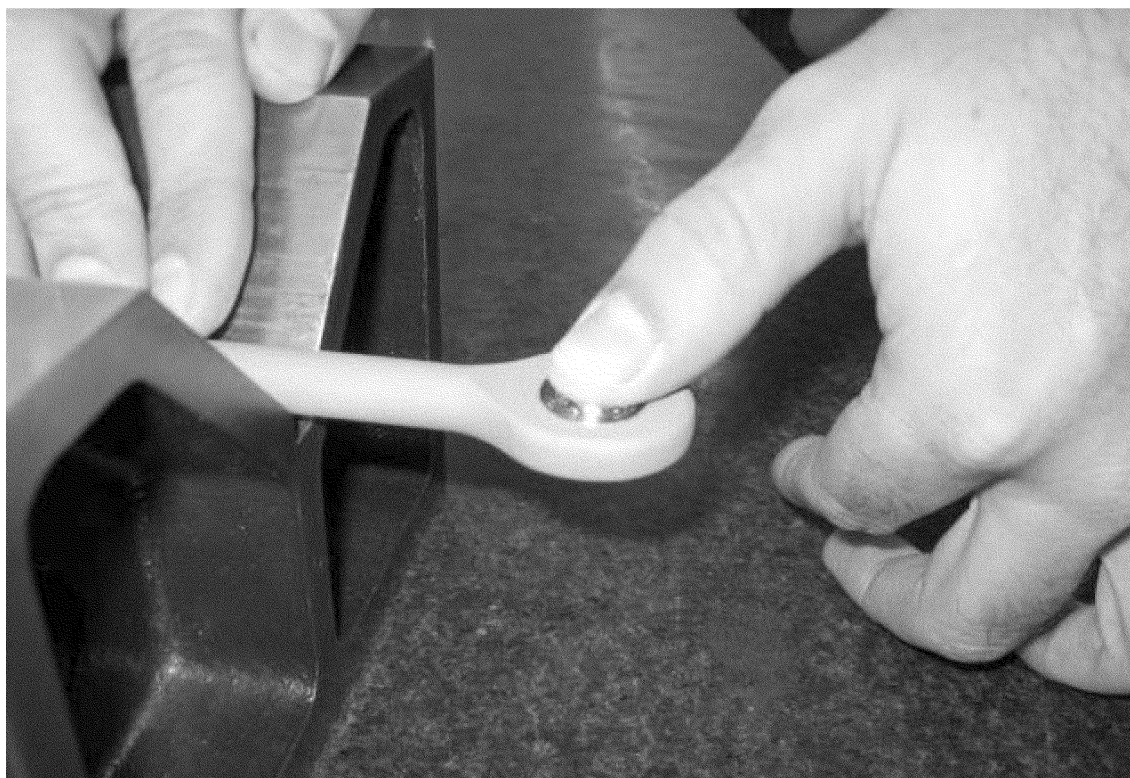
- (1) Remove the pitch link.
- (2) Clean the area around the spherical bearings and pitch link bearing bore chamfer.
- (3) Apply axial hand pressure to the faces of both spherical bearings as shown in Figure 1 to Paragraph (e) of this AD.
