[Docket No. 2003-NM-209-AD; Amendment 39-13353; AD 2003-19-51]

Airworthiness Directives; Bombardier Model CL-600-2C10 (Regional Jet Series 700 & 701) and CL-600-2D24 (Regional Jet Series 900) Series Airplanes

2003-19-51 Bombardier, Inc. (Formerly Canadair): Amendment 39-13353. Docket 2003-NM-209-AD.

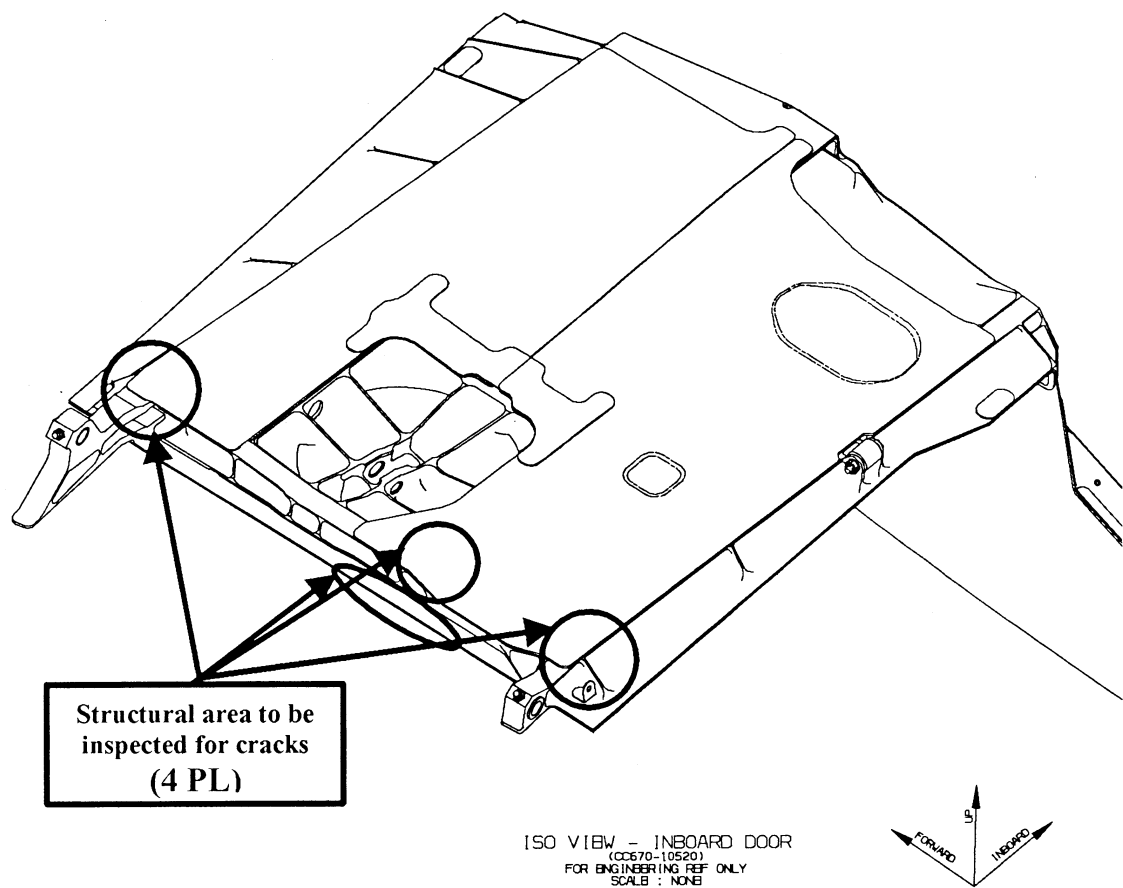
Figure 1
LH side shown
RH side opposite

(b) Perform detailed inspections of the lower panel, P/N CC670-10520, of the left- and right-hand MLG doors for the conditions and in the areas specified in paragraphs (b)(1), (b)(2), (b)(3), and (b)(4) of this AD; and Figures 1, 2, and 3 of this AD.
