[Docket No. FAA-2007-28661; Directorate Identifier 2007-NM-013-AD]

Airworthiness Directives; The Boeing Company Model 737-600, -700, -700C, -800, and -900 Series Airplanes

ACTION: Supplemental notice of proposed rulemaking (NPRM); reopening of comment period.

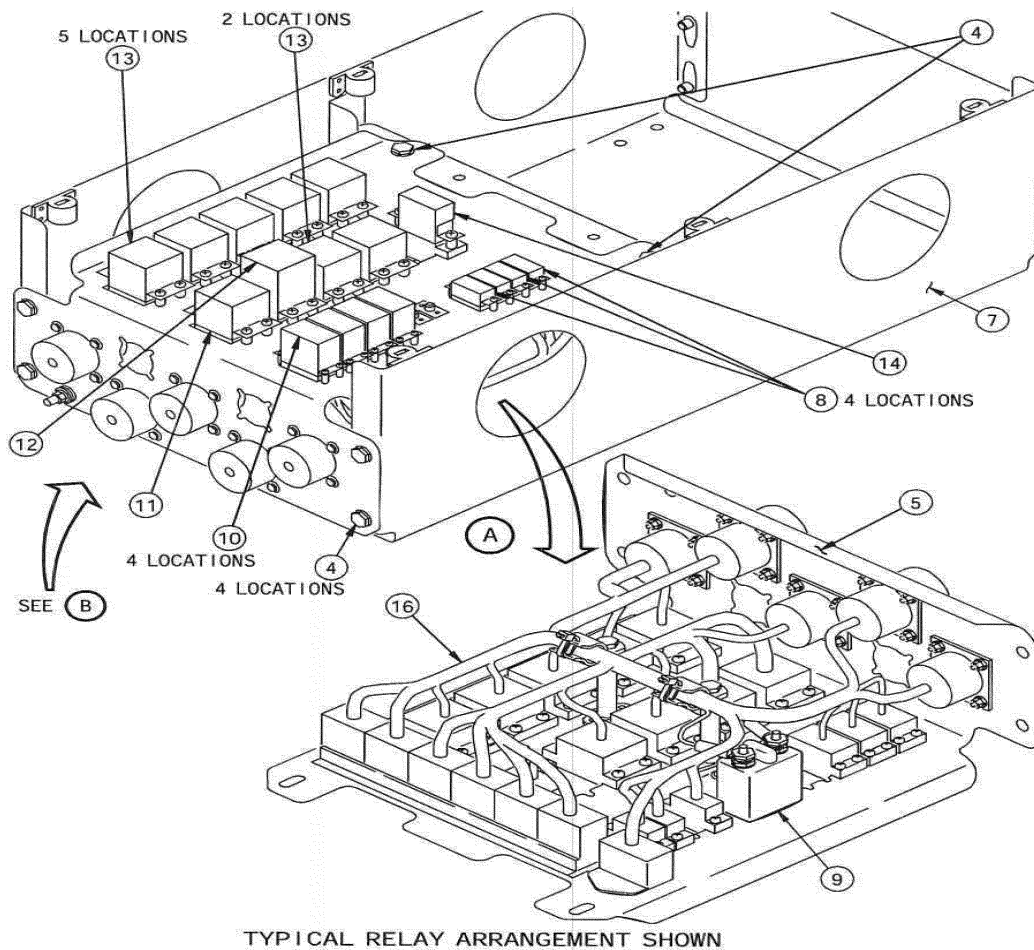
- Sheet 2 of 4 of Figure 11 of Boeing Alert Service Bulletin 737-28A1206, Revision 2, dated May 21, 2009, was inadvertently replaced with Sheet 2 of 4 of Figure 11 from Boeing Alert Service Bulletin 737-28A1206, dated January 11, 2006. That figure was corrected in Boeing Alert Service Bulletin 737-28A1206, Revision 1, dated January 30,

2008, and did not need to be changed in Boeing Alert Service Bulletin 737–28A1206, Revision 2, dated May 21, 2009. We have added Figure 1 in this supplemental NPRM to provide the correct Sheet 2 of 4 of Figure 11.

Placard Installation for Mixed Fleet Operation
