[Docket No. FAA-2006-25097; Directorate Identifier 2005-SW-19-AD]

**Airworthiness Directives; Arrow Falcon Exporters, Inc. (Previously Utah State University); Firefly Aviation Helicopter Services (Previously Erickson Air-Crane Co.); California Department of Forestry; Garlick Helicopters, Inc.; Global Helicopter Technology, Inc.; Hagglund Helicopters, LLC (Previously Western International Aviation, Inc.); International Helicopters, Inc.; Precision Helicopters, LLC; Robinson Air Crane, Inc.; San Joaquin Helicopters (Previously Hawkins and Powers Aviation, Inc.); S.M.&T. Aircraft (Previously US Helicopters, Inc., UNC Helicopter, Inc., Southern Aero Corporation, and Wilco Aviation); Smith Helicopters; Southern Helicopter, Inc.; Southwest Florida Aviation International, Inc. (Previously Jamie R. Hill and Southwest Florida Aviation); Tamarack Helicopters, Inc. (Previously Ranger Helicopter Services, Inc.); US Helicopter, Inc. (Previously UNC Helicopter, Inc.); West Coast Fabrication; and Williams Helicopter Corporation (Previously Scott Paper Co.) Model HH-1K, TH-1F, TH-1L, UH-1A, UH-1B, UH-1E, UH-1F, UH-1H, UH-1L, and UH-1P Helicopters; and Southwest Florida Aviation Model SW204, SW204

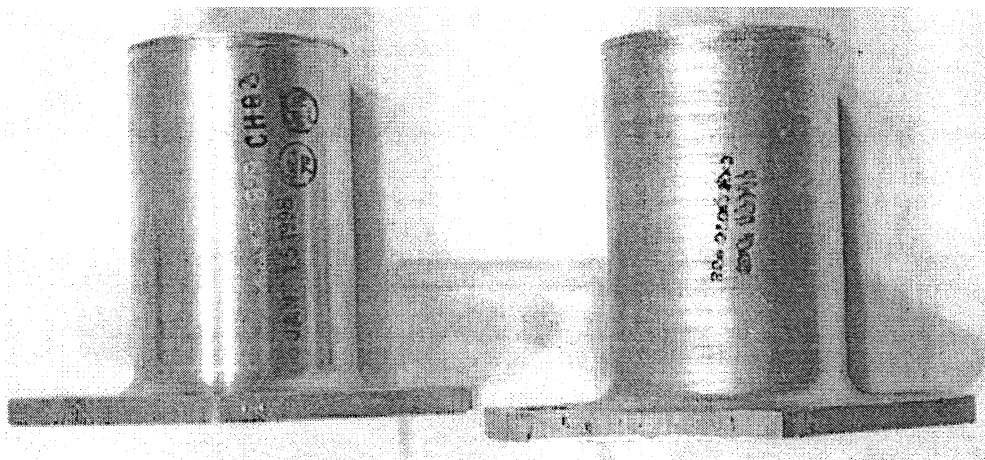
FIGURE 1

**Note 1:** T/R sliders manufactured by Forest Scientific, Inc., were produced under a military contract and do not meet the OEM specifications. The machining process resulted in excess surface roughness. See Figure 1 of this AD.

Tail rotor sliders manufactured by Bell Helicopter Textron, Inc. (left) and Forest Scientific, Inc. (right). Note the rough finish of the Forest Scientific, Inc.-manufactured T/R slider compared to the one shown on the left.

(iii) On or before accumulating 1000 hours TIS or on or before 12 months, whichever occurs first, replace each T/R slider that

has an illegible CAGE code or Code 15716 or 26098 with an FAA approved airworthy slider without a CAGE code or with a legible CAGE code other than 15716 or 26098. Any T/R slider removed from service based on the requirements of this paragraph is not eligible for installation on any helicopter.
