Federal Register

[Docket No. FAA-2008-0071; Directorate Identifier 2006-SW-27-AD; Amendment 39-16291; AD 2010-10-12]

Airworthiness Directives; Bell Helicopter Textron Canada Model 222, 222B, 222U, 230, and 430 Helicopters

2010–10–12 Bell Helicopter Textron

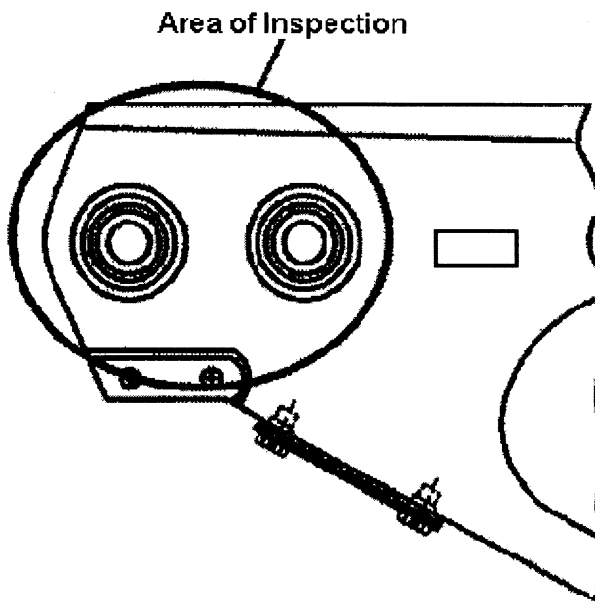
the specified BHTC model helicopters. Transport Canada advises of the discovery of cracked blades during scheduled inspections on three occasions. Two cracks originated from the outboard feathering bearing bore underneath the flanged sleeves. The third crack started from the inboard feathering bearing bore. Investigation found that the cracks originated from either a machining burr or a corrosion site in the bearing bore underneath the flanged sleeves.

(a) Within 3 hours time-in-service (TIS), unless accomplished previously, and thereafter at intervals not to exceed 3 hours TIS, clean and visually check both sides of each blade for a crack in the paint in the areas shown in Figure

Blade Inspection Area

(c) Within the next 50 hours TIS, unless accomplished previously, and thereafter at intervals not to exceed 50 hours TIS, clean the blade by wiping down both surfaces of each blade in the inspection area depicted in Figure 1 of this AD using aliphatic naphtha (C-305) or detergent (C-318) or an equivalent. Using a 10X or higher power magnifying glass, visually inspect both sides of the blade in the areas depicted in Figure 1 of this AD.

(1) If a crack is found, even if only in the paint, before further flight, remove the blade from the helicopter and proceed with the following:

(2) Remove the paint on the blade down to the bare metal in the area of the suspected crack by using plastic media blasting (PMB) or a nylon web abrasive pad. Abrade the blade surface in a spanwise direction only.

(3) Using a 10X or higher power magnifying glass, inspect the blade for a crack.

(i) If a crack is found, replace the blade with an airworthy blade before further flight.

(ii) If no crack is found in the blade surface, refinish the blade by applying one coat of epoxy polyamide primer, MIL-P-23377 or MIL-P-85582, so that the primer overlaps the existing coats just beyond the abraded area. Let the area dry for 30 minutes to 1 hour. Then,

apply one sealer coat of polyurethane, MILC85285 TYI CL2, color number 27925 (semi-gloss white). Reinstall the blade.

(d) On or before 90 days after the effective date of this AD, replace any affected serial-numbered blade with an airworthy blade that has a S/N that is not subject to, or has been excepted from, the requirements of this AD. Installing an airworthy blade that is not subject to the requirements of this AD, or has been excepted from the requirements of this AD, including those blades with an "R" code in the square block below the part number field of the Data Plate, constitute a terminating action for the requirements of this AD.
