[Docket No. FAA-2012-1018; Directorate Identifier 2011-SW-052-AD; Amendment 39-17204; AD 2012-19-09]

Airworthiness Directives; Eurocopter France Helicopters

2012-19-09 Eurocopter Helicopters:

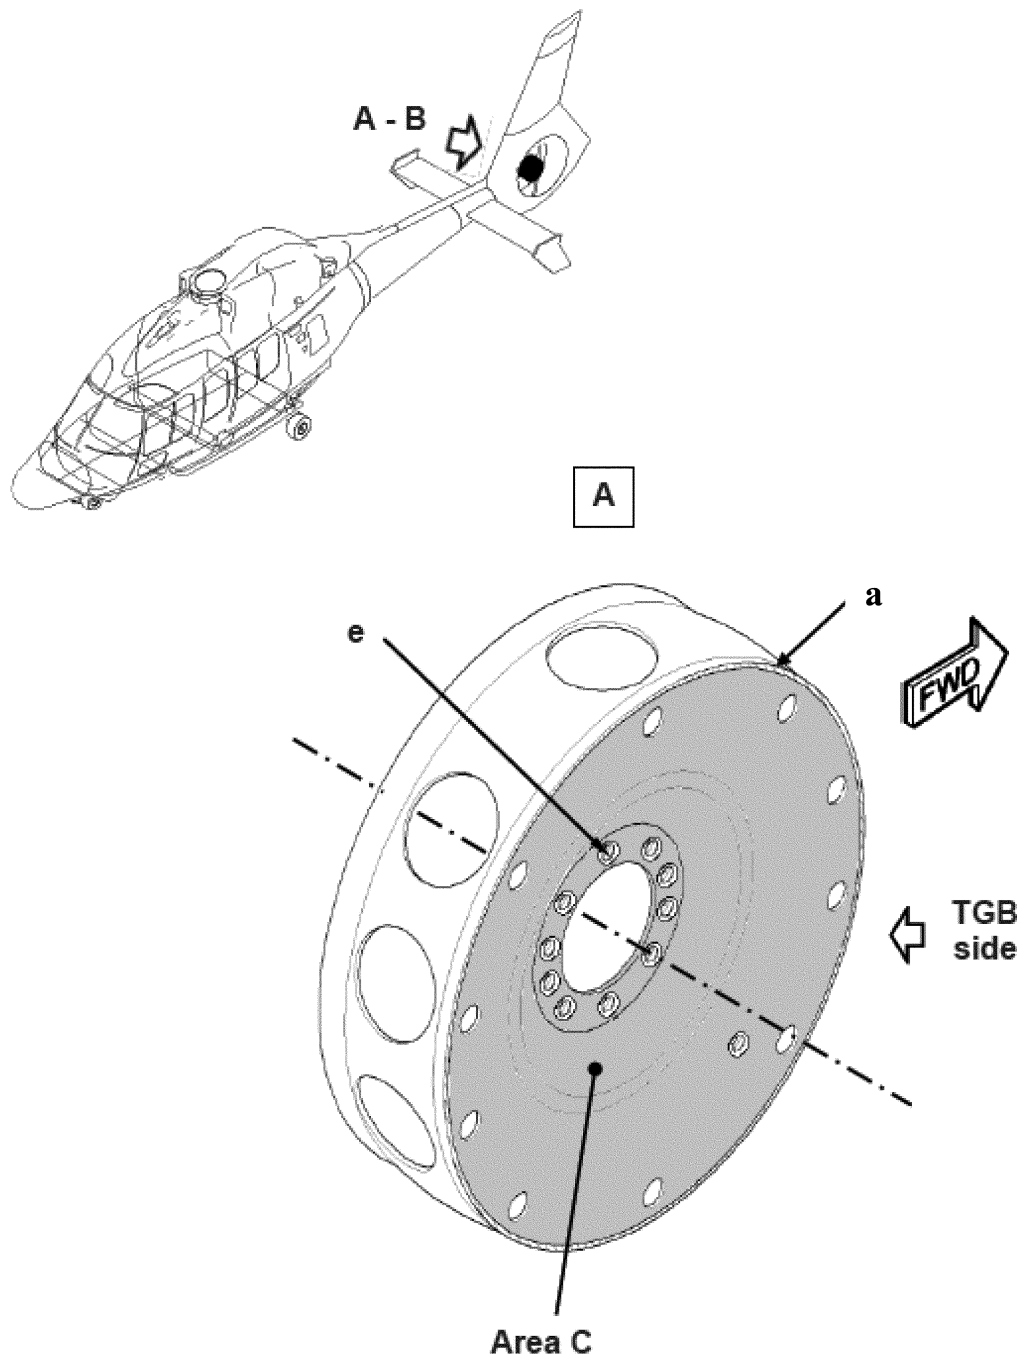
Figure 1 to Paragraph (e)(1) TRH Hub

(1) Within 55 hours time-in-service (TIS), and thereafter at intervals not to exceed 55 hours TIS, using a light, visually inspect the TRH for a crack in the entire area shown as Area C of the TRH (a) in Figure 1 to paragraph (e)(1) of this AD. The inspection area is on the tail gearbox (TGB) side of the TRH. The TGB is shown as (c) in Figures 2 and 3 to paragraph (e)(1) of this AD. You must pay particular attention to the area around the screws, shown as (e) in Figure 3 to paragraph (e)(1) of this AD, and the TRH between the lower part of the TGB and its fairing, shown as (d) in Figures 2 and 3 to paragraph (e)(1) of this AD, using details D and E of Figure 3 to paragraph (e)(1) of this AD. You must turn the tail rotor by hand to inspect the entire Area C.

(2) If there is a crack on the TRH, remove the TRH from service.
