Safety Advisory 2023-05; King Pin Assemblies in Highway-Rail Grade Crossing Warning Systems

ACTION: Notice of safety advisory.

SUMMARY: FRA is issuing Safety Advisory 2023-05 to heighten awareness within the railroad industry of the potential failure of king pin assemblies in highway-rail grade crossing warning systems equipped with breakaway gates. This Safety Advisory recommends that railroads inspect and replace all worn components in king pin assemblies. This Safety Advisory also recommends that railroads develop inspection and

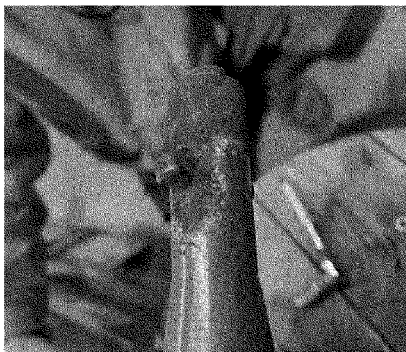
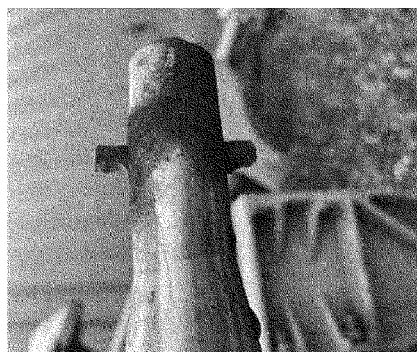
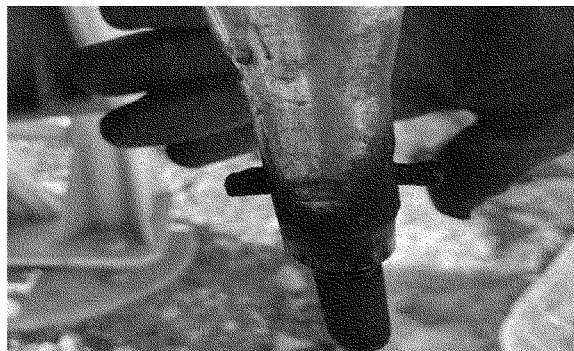
However, the king pin assembly can be damaged under normal operating conditions by vehicle strikes, high winds, rust, worn gate boot(s), and corrosion. If the highway-rail grade crossing gate is being held in place by a worn or damaged king pin assembly, the crossing gate may drop off the king pin and post pin tabs. When this occurs, the crossing gate may be held in place by only the shear bolts, which are not designed to hold the weight of the crossing gate. Therefore, if relied upon to hold the crossing gate in place, the shear bolts could stretch and break unexpectedly, allowing the crossing gate to fall. This could happen very quickly, potentially causing injury to railroad employees or members of the general public in close proximity to the crossing gate.

*Figures 4,5,6-Heavily oxidized and worn king pin tabs*

(1) Inspect king pin assemblies in highway-rail grade crossing warning systems and replace all worn components.

(2) Develop inspection and maintenance programs for king pin assemblies that incorporate maintenance procedures recommended by the manufacturer (if applicable), including lubrication of king pin assemblies to reduce wear and tear on the components. These inspection and maintenance programs should include periodic inspections of the king pin assembly with the crossing gate removed, as well as inspection of the king pin assembly each time the crossing gate is re-hung or replaced. These inspection and maintenance programs should also address the replacement of worn components and give special consideration to highway-

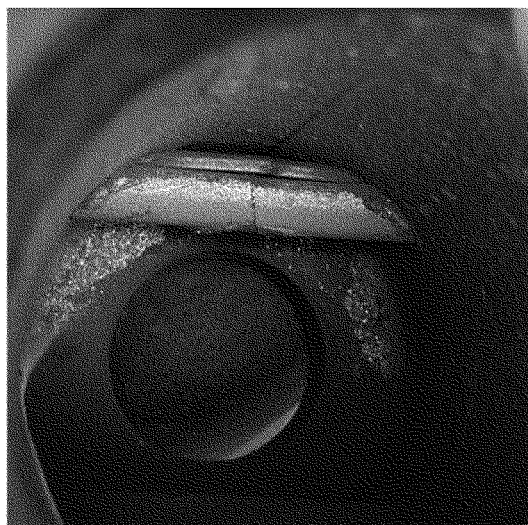
Figure 7-Roll pin crack on king pin
