[Docket No. FAA–2022–0459; Project Identifier MCAI–2021–00266–E; Amendment 39–22102; AD 2022–13–16]

Airworthiness Directives; GE Aviation Czech s.r.o. (Type Certificate Previously held by WALTER Engines a.s., Walter a.s., and MOTORLET a.s.) Turboprop Engines

ACTION: Final rule.

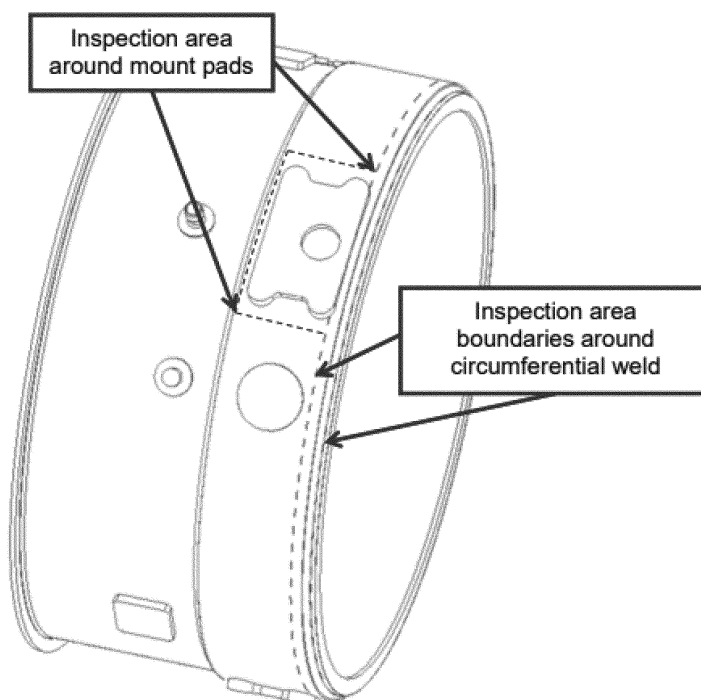
Figure 1. Centrifugal Compressor Case

This AD was prompted by the manufacturer revising the airworthiness limitations section (ALS) of the existing engine maintenance manual (EMM) to include a visual inspection of the centrifugal compressor case for cracks. The FAA is issuing this AD to prevent failure of the centrifugal compressor case. The unsafe condition, if not addressed, could result in failure of the centrifugal compressor case, engine separation, and loss of the airplane.

Do a visual inspection of the compressor case in the specified areas, shown in Figure 1, for every 100±10 Flight Hours. Use magnifying lens 10x for inspection. No visible cracks are allowed.

(1) Within 90 days after the effective date of this AD, revise the ALS of the existing EMM by incorporating Figure 1 to paragraph (g)(1) of this AD.

- A 150-watt standard spotlight or 40-watt high intensity spotlight or alternative (Commercial) to acquire necessary illumination at minimum 1000lux.
- Magnification equipment 10x (Commercial).
