#### Airworthiness Directives; GE Aviation Czech s.r.o. (Type Certificate Previously Held by WALTER Engines a.s., Walter a.s., and MOTORLET a.s.) Turboprop Engines

**ACTION:** Notice of proposed rulemaking (NPRM).

## Figure 1 to Paragraph (g)(1) – Visual Inspection of the Centrifugal Compressor Case

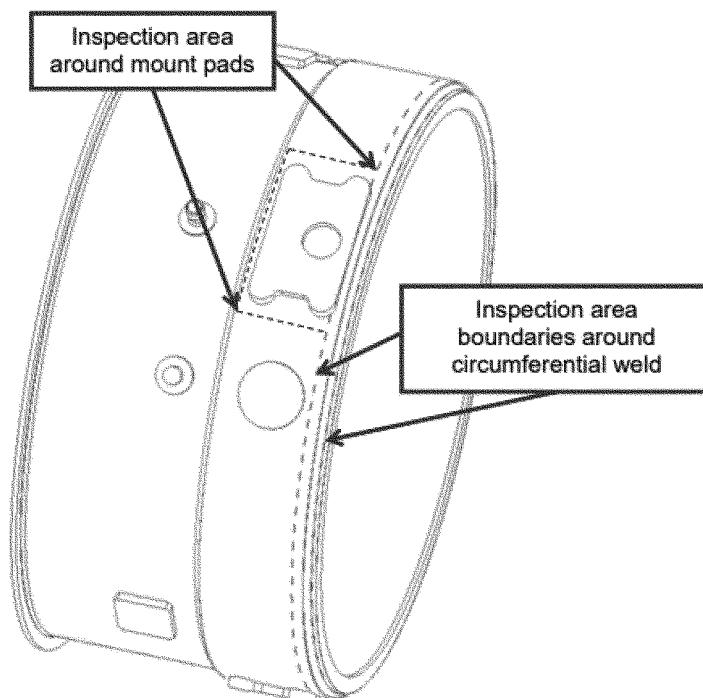
Figure 1. Centrifugal Compressor Case

engine maintenance manual (EMM) to include a visual inspection of the centrifugal compressor case for cracks. The FAA is issuing this AD to prevent failure of the centrifugal compressor case. The unsafe condition, if not addressed, could result in failure of the centrifugal compressor case, engine separation, and loss of the airplane.

Do a visual inspection of the compressor case in the specified areas, shown in Figure 1, for every 100±10 Flight Hours. Use magnifying lens 10x for inspection. No visible cracks are allowed.

(1) Within 90 days after the effective date of this AD, revise the ALS of the existing EMM by incorporating Figure 1 to paragraph (g)(1) of this AD.
