[Docket No. FAA–2014–0337; Directorate Identifier 2013–SW–029–AD; Amendment 39–18008; AD 2014–22–03]

#### Airworthiness Directives; Various Restricted Category Helicopters

#### 2014–22–03 Various Restricted Category

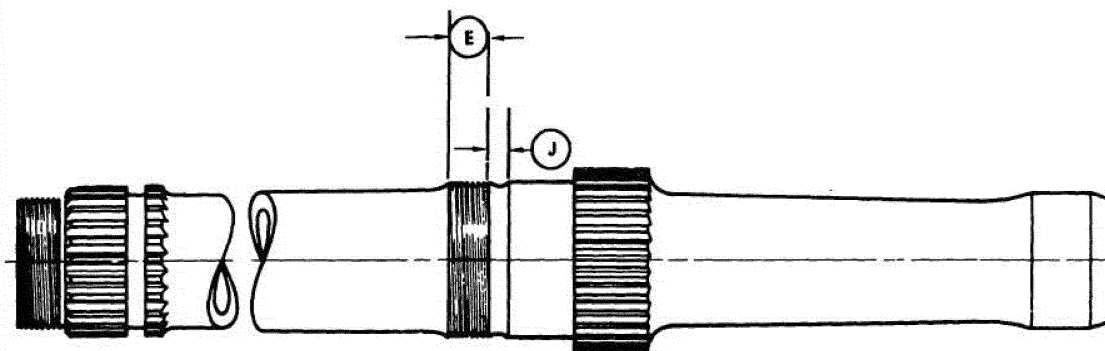
This AD defines the unsafe condition as a crack in the main rotor mast, which could result in failure of the mast and subsequent loss of control of the helicopter.

(i) Remove any surface rust with a wire brush or steel wool and, using a 10X or higher power magnifying glass, inspect the areas of the mast as shown in area E and area J of Figure 1 to Paragraph (f) of this AD for pitting, corrosion, or a crack.

- (2) If there is a crack, pitting, or corrosion, before further flight, replace the mast with an airworthy mast.
