[Docket No. FAA–2010–0342; Directorate Identifier 2002–NE–08–AD]

Airworthiness Directives; Bombardier-Rotax GmbH Type 912 F, 912 S, and 914 F Series Reciprocating Engines

ACTION: Notice of proposed rulemaking (NPRM).

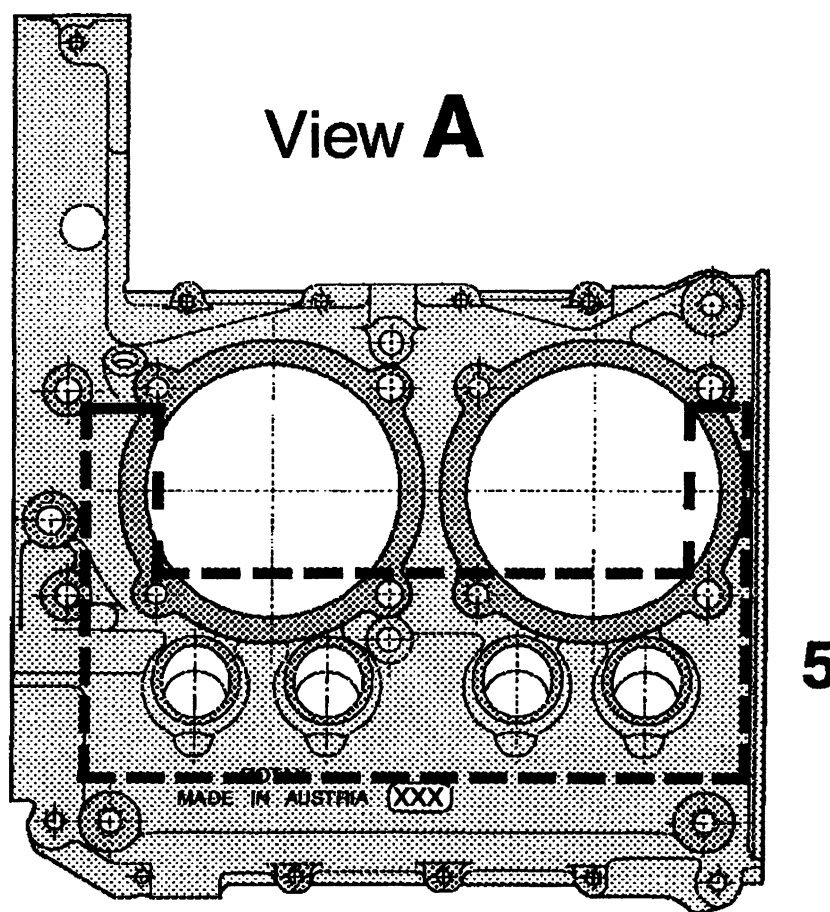
Figure 2. Engine Crankcase Inspection Areas – View A

(f) Determine if your crankcase is affected by looking at the S/N in the area indicated by XXX, following “Made in Austria,” as shown on Figure 2 of this AD. The marking is on both crankcase halves.

(1) Inspect the engine crankcase (item 1, Figure 1 of this AD) for cracks, especially in the area of cylinder 1 upper side (item 2), between cylinder 1 and 3 upper side (item 3), cylinder 4 lower-right side (item 4) and detailed inspection in the area identified in Figure 2 (item 5) of this AD. Information concerning this inspection can be found in Bombardier-Rotax Mandatory Service Bulletins No. SB–912–029, Revision 3, dated July 11, 2006 and No. SB–914–018, Revision 3, dated July 11, 2006.

(k) Installing a crankcase that has a S/N above 27811 terminates the inspection requirements of paragraphs (g)(1) through (g)(4) and (h) of this AD.
