[Docket No. FAA–2009–1253; Directorate Identifier 2009–NM–080–AD; Amendment 39–16629; AD 2011–06–05]

#### **Airworthiness Directives; The Boeing Company Model 737–600, –700, –700C, –800, –900, and –900ER Series Airplanes**

**ACTION:** Final rule.

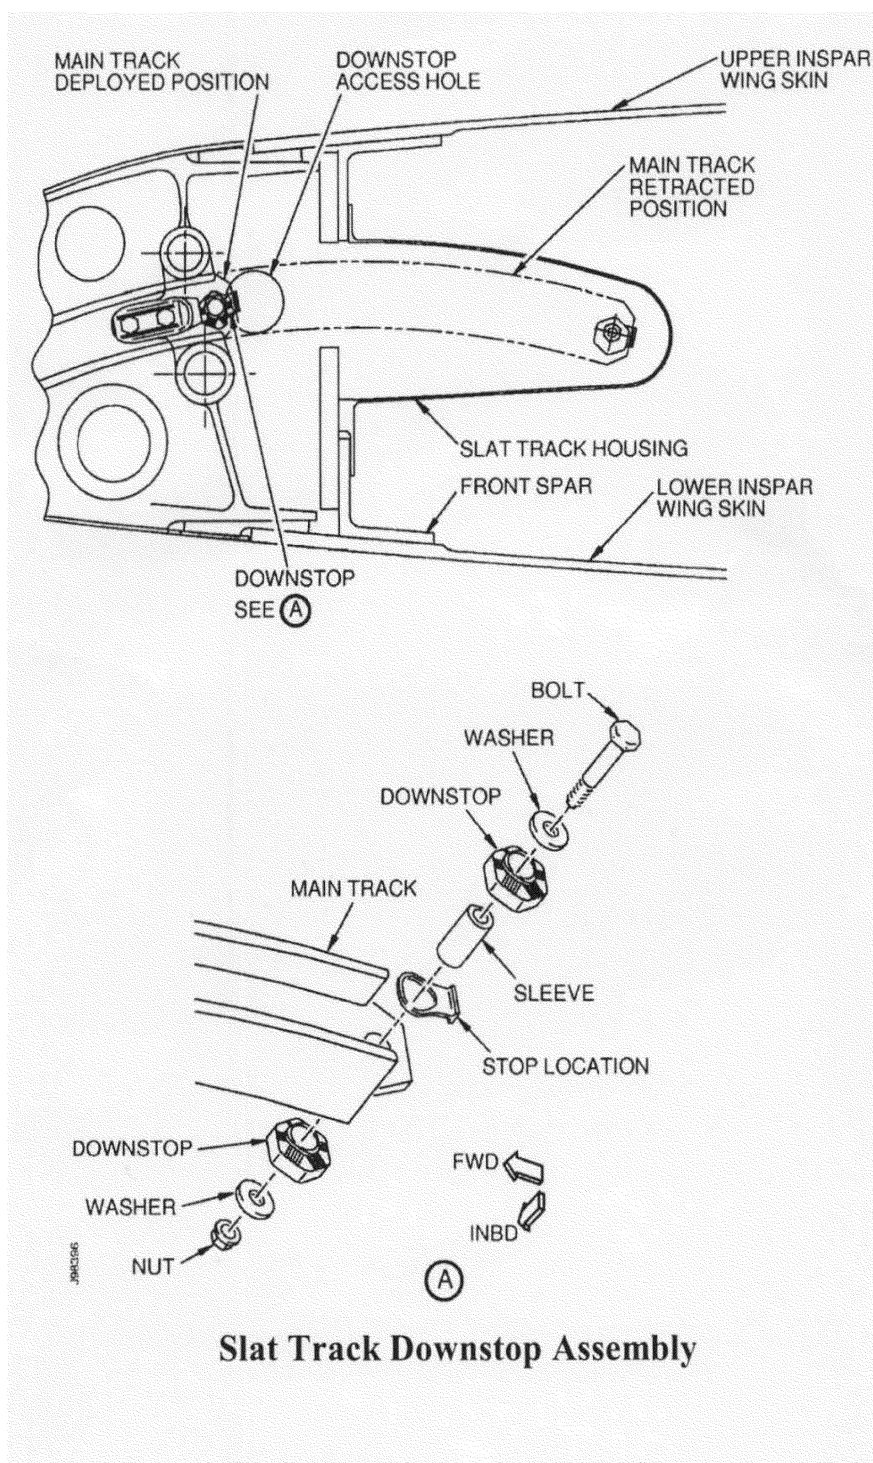
**Figure 1**

(g) Within 10 days after September 26, 2007 (the effective date of AD 2007–18–52): Do a detailed inspection or a borescope inspection of each main slat track downstop assembly to verify proper installation of the slat track hardware (*i.e.*, the bolt, washers, downstops, stop location, and nut shown in Figure 1 of Boeing Service Letter 737–SL–57–084–B, dated July 10, 2007, and in this AD). Proper installation of the sleeve need not be confirmed, and the stop location part may be installed on either the inboard or the outboard side of the slat track. If any part is missing or is installed improperly, before further flight, install a new or serviceable part using a method approved in accordance with the procedures specified in paragraph (j) of this AD; and do a detailed inspection of the inside of the slat can for foreign object debris (FOD) and damage. Before further flight, remove any FOD found and repair any damage found using a method approved in accordance with the procedures specified in paragraph (j) of this AD. Verify proper installation; install a new or serviceable part; and inspect for damage and FOD, and remove FOD and repair damage; in accordance with a method by approved by the Manager, Seattle Aircraft Certification Office, FAA; or in accordance with Boeing Multi Operator Message Number 1–523812011–1, issued August 25, 2007, or 1–527463441–1, issued August 28, 2007. Repeat the actions required by paragraph (g) of this AD thereafter at intervals not to exceed 3,000 flight cycles.

(h) Within 24 days after receipt of emergency AD 2007–18–51: Apply a torque between 50 to 80 inch-pounds to the nut. The bolt head must be held with the torque applied to the nut.
