Federal Register

[Docket No. FAA-2025-0011; Project Identifier AD-2024-00618-R]

Airworthiness Directives; Robinson Helicopter Company Helicopters

ACTION: Notice of proposed rulemaking (NPRM).

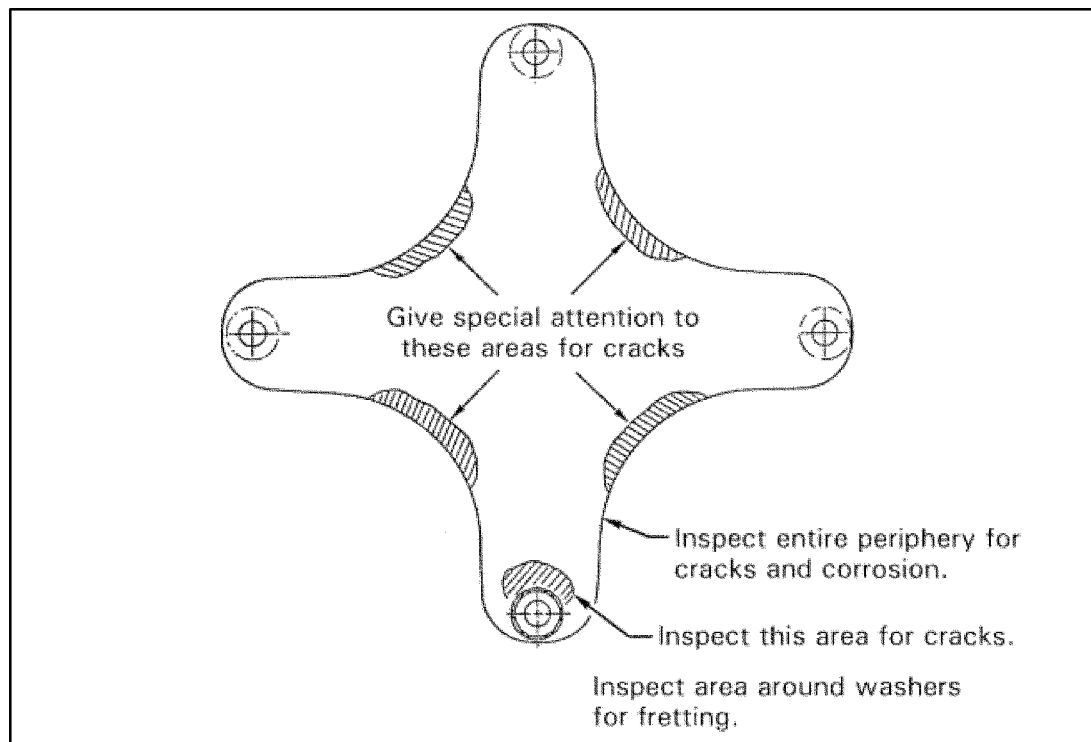
Figure 1 to Paragraph (g)(1)(i)—Flex Plate Inspection

(i) Visually inspect forward flex plate assembly part number (P/N) C947–1 (flex plate) for any loose fasteners, cracks, fretting, corrosion, wear, and to ensure that the washers are bonded to both sides of each flex plate arm, in the areas depicted in Figure 1 to paragraph (g)(1)(i) of this AD. If there is any loose fastener (can be moved by hand), crack, fretting, corrosion, or wear that consists of the washers not securely bonded to both sides of each flex plate arm, before further flight, remove the flex plate from service and replace it with an airworthy flex plate.
