[Docket No. FAA-2012-1128; Directorate Identifier 2012-SW-064-AD; Amendment 39-17225; AD 2012-21-09]

Airworthiness Directives; Eurocopter France Helicopters

2012–21–09 Eurocopter France:

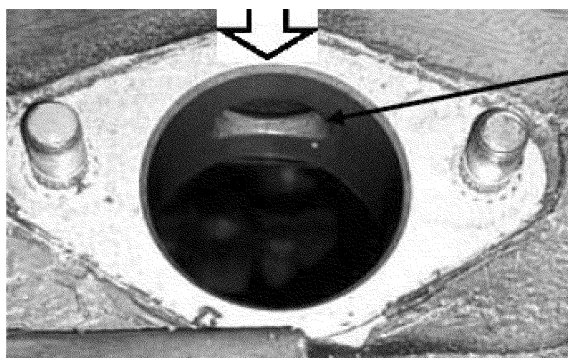
Figure 1 to paragraph (e)(1)(ii)

This AD defines the unsafe condition as a missing through-hole, joining the integrated collector to the magnetic plug. This condition could result in failure of the chip-detector system to detect deterioration of the main rotor mast lift bearing, failure of the lift bearing, and subsequent loss of control of the helicopter.

(ii) Determine if the hole above the magnetic plug is a through-hole as shown in figures 1 and 2 to paragraph (e)(1)(ii) of this AD.

(2) If the hole above the magnetic plug is not a through-hole, before further flight,

replace the epicyclic module with an airworthy epicyclic module.
