[Docket No. 2000-SW-29-AD; Amendment 39-11894; AD 2000-18-09]

#### Airworthiness Directives; Bell Helicopter Textron, Inc. Model 412, 412EP, and 412CF Helicopters

**2000-18-09—Bell Helicopter Textron, Inc.:**  
Amendment 39-11894. Docket No. 2000-SW-29-AD.

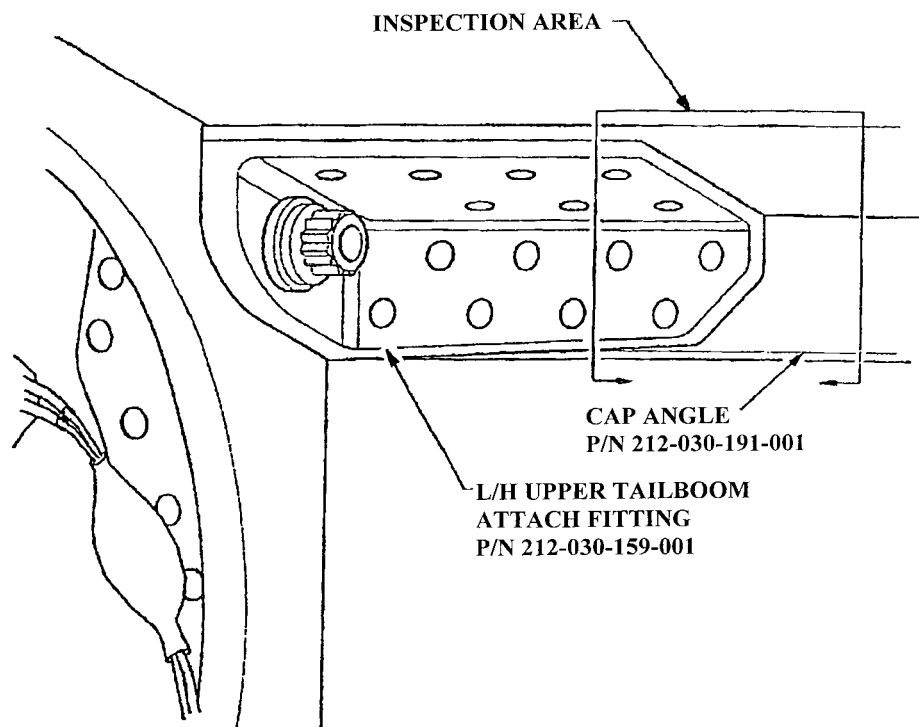
This AD is prompted by a report of a fatigue crack in a tailboom attachment cap angle. This condition, if not corrected, could result in loss of the tailboom and subsequent loss of control of the helicopter.

(a) Within 25 hours time-in-service (TIS) and thereafter at intervals not to exceed 100 hours TIS, inspect the cap angle and adjacent structure for a crack in the area shown in figure 1. Use a 10-power or higher magnifying glass.

Figure 1 Fuselage Tailboom Attachment Inspection

(1) If a crack is found in the cap angle, replace it with an airworthy cap angle before further flight.

(2) Repair any crack found in the adjacent structure before further flight.
