[Docket No. 2000-SW-12-AD; Amendment 39-13354; AD 2003-22-06]

Airworthiness Directives; Eurocopter France Model AS350B, B1, B2, B3, BA, C, D, D1, and AS355E, F, F1, F2, and N Helicopters

2003-22-06 Eurocopter France:

Amendment 39-13354. Docket No. 2000-SW-12-AD. Supersedes AD 98-24-35, Amendment 39-10921, Docket No. 98-SW-41-AD.

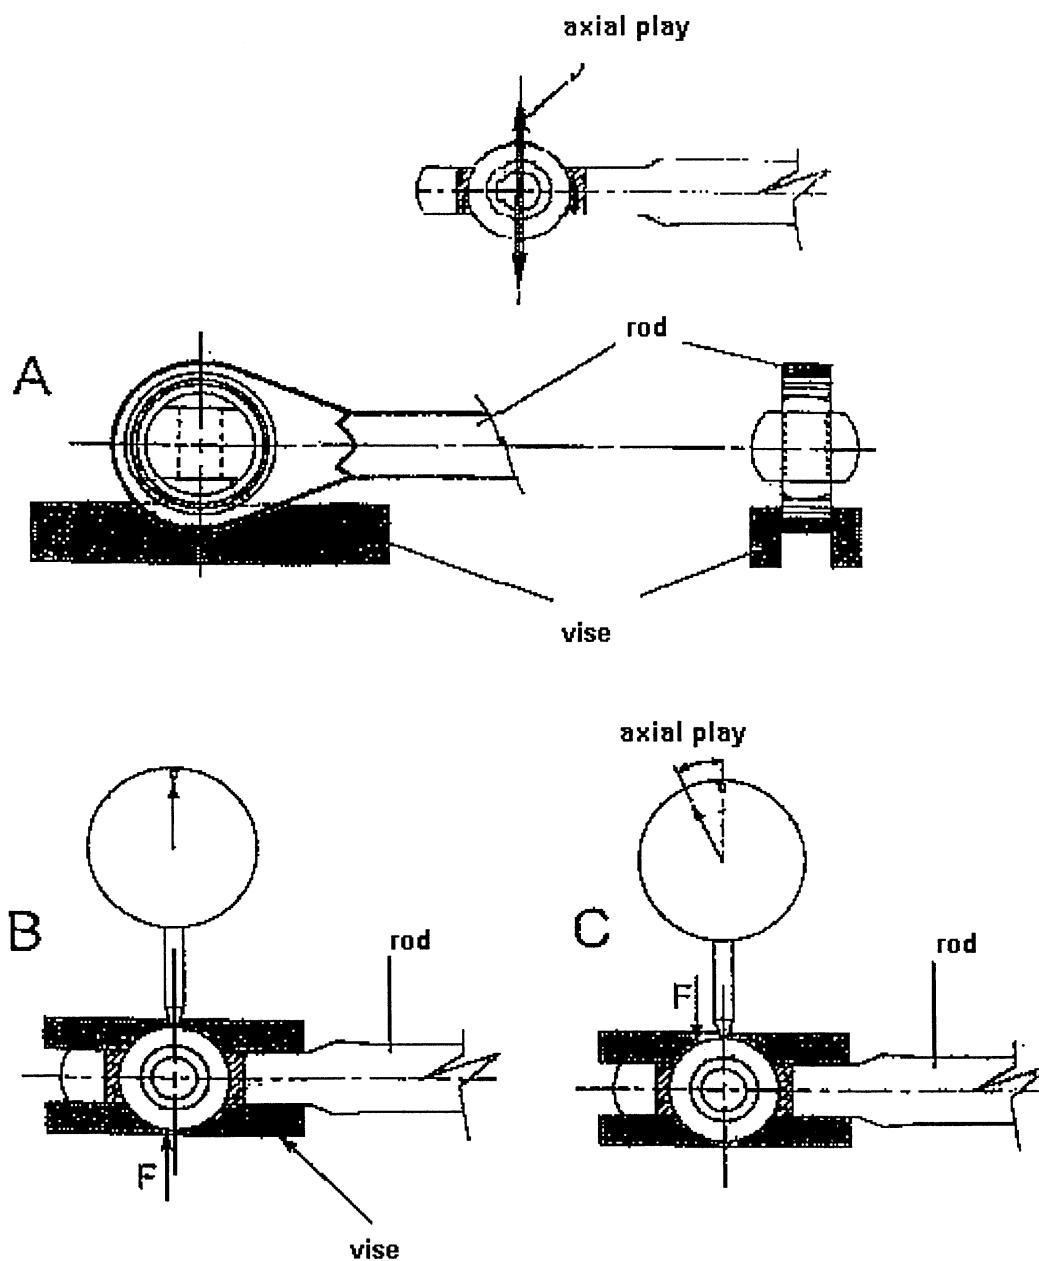
Figure 2: Measurement of the Axial Play (A) of the Bearing

(2) Mount the control rod in a vise as shown in Figure 2 of this AD.

(3) Using a dial indicator, take axial play readings by moving the spherical bearing in the direction F (up and down) as shown in Figure 2 of this AD.

(7) If the radial play exceeds 0.008 inch or axial play exceeds 0.016 inch, replace the control rod with an airworthy control rod before further flight.
