Federal Register

[Docket No. 2001-SW-17-AD]

Airworthiness Directives; Bell Helicopter Textron, Inc.—Manufactured Model OH-13E, OH-13H, and OH-13S Helicopters

ACTION: Notice of proposed rulemaking (NPRM).

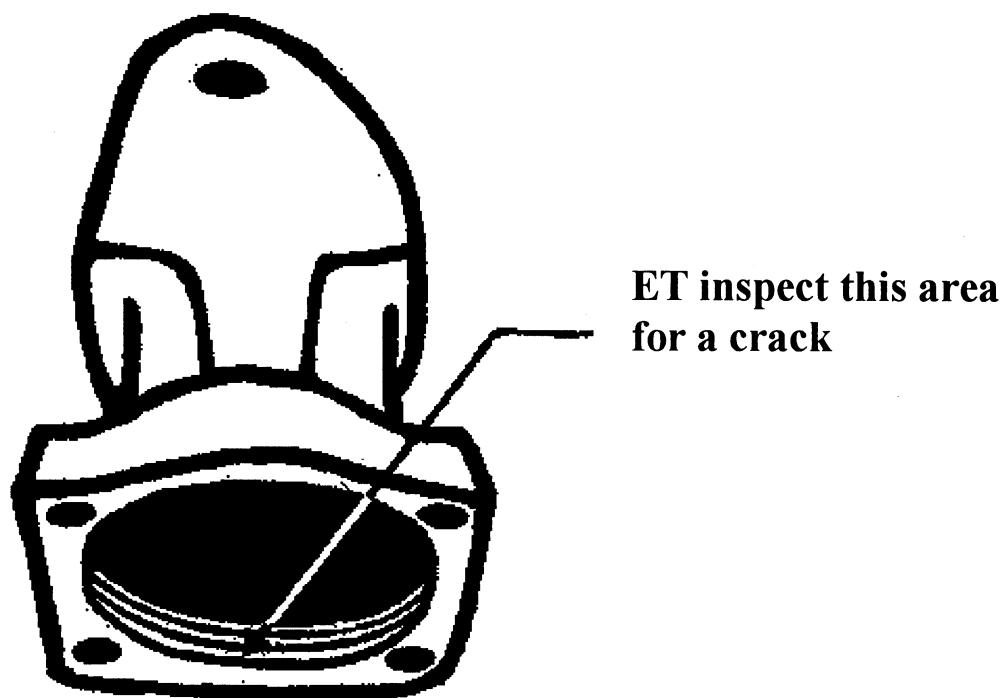
**Figure 1, Appendix 1**

- 1.1 The inboard inside diameter machined threads (reference Figure 1).

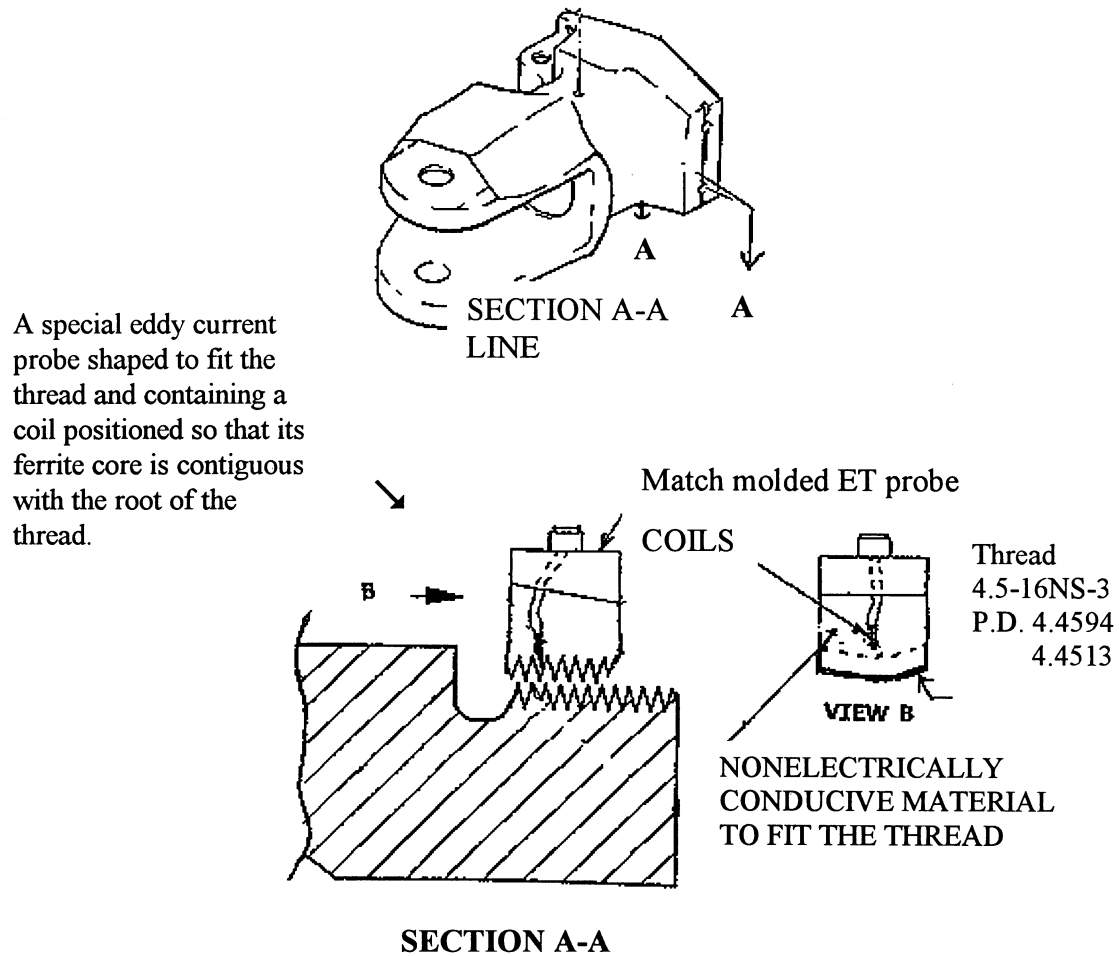
**Figure 3, Appendix 1**

- 2.1 Zetec Miz-20/22, Phasec 2200 or equivalent piece of equipment.
2.2 Match molded ET probe SPC-193 (100kHz) or equivalent. (See Figure 3.)
2.3 Reference standard EC-010-021, or equivalent. (See Figures 4 and 5.)
2.4 Light oil.

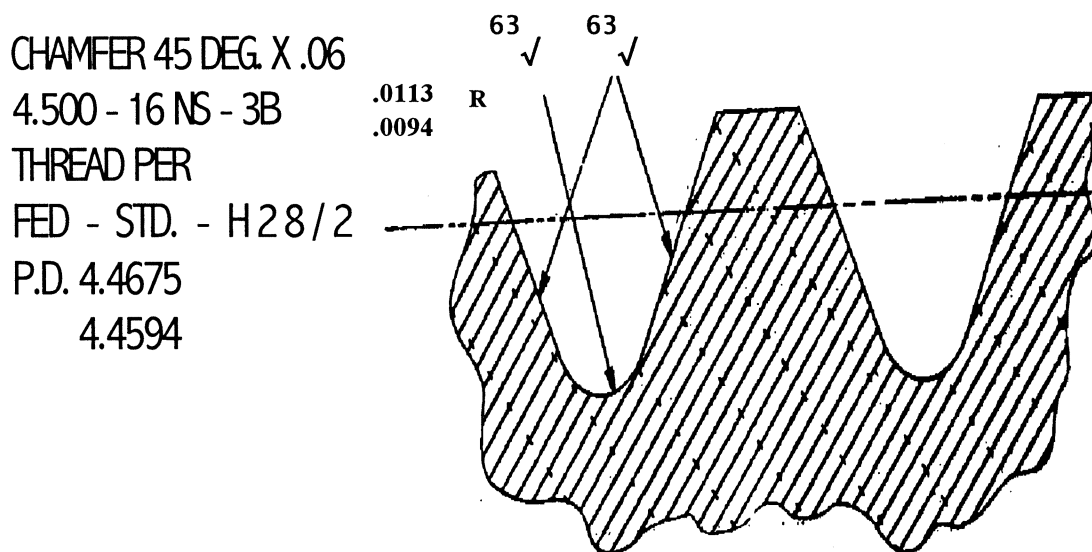
**Figure 5, Appendix 1**

1. Standard may be machined from aluminum tube stock.
2. The standard shall contain a minimum of four teeth per the tooth dimensions specified.
3. The EDM notch shall be placed in the center most tooth root as measured across the width of the standards. There shall be no less than two teeth and one root on either side of the EDM notch.
