[Docket No. FAA-2012-0630; Directorate Identifier 2011-SW-010-AD]

#### Airworthiness Directives; Eurocopter France Helicopters

**ACTION:** Notice of proposed rulemaking (NPRM).

**SUMMARY:** We propose to adopt a new airworthiness directive (AD) for Eurocopter France EC130B4 helicopters. This proposed AD is prompted by an in-flight cracking and failure of a center windscreen. The proposed actions are intended to detect a crack in the blending radii of the center windscreen to prevent failure of the windscreen, injury to the flight crew, and subsequent loss of control of the helicopter.

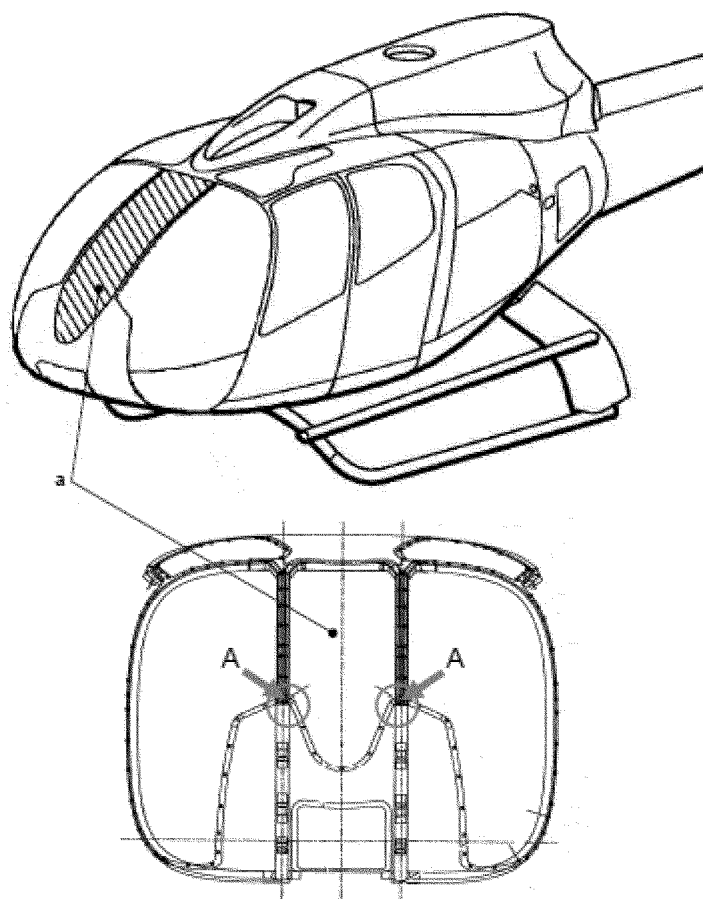
**Figure 1**

This AD defines the unsafe condition as a crack in the blending radii of the center windscreen, which could lead to failure of the center windscreen, injury to the flight crew, and subsequent loss of control of the helicopter.

(1) Until the center windscreen is replaced with center windscreen P/N 350A25–9045–20, before each flight, visually check the center windscreen for a crack in the area of the blending radii where the front-lower part of the center windscreen joins the front fuselage as depicted in Figure 1 of this AD. This visual check may be performed by the owner/operator (pilot) holding at least a private pilot certificate, and must be entered into the aircraft records showing compliance with the AD in accordance with Title 14 Code of Federal Regulations (14 CFR) 43.9 (a)(1)–(4) and 14 CFR 91.417(a)(2)(v). The record must be maintained as required by 14 CFR 91.417, 121.380, or 135.439.

(2) If there is a crack or if a pilot indicates that the center windscreen distorted during flight, before further flight, replace the center windscreen with an airworthy center windscreen, P/N 350A25-9045-20, in accordance with the Accomplishment Instructions, paragraphs 2.B.2.b. through 2.B.2.b.4. of Eurocopter Service Bulletin No. 56-003, Revision 0, dated November 16, 2010.

(3) Within 12 months, replace the center windscreen with an airworthy center windscreen, P/N 350A25-9045-20, in accordance with the instructions contained in paragraph (d)(2) of this AD.

(4) Replacing the center windscreen with center windscreen, P/N 350A25-9045-20, constitutes terminating action for the requirements of this AD.
