Federal Register

[Docket No. FAA-2012-0409; Directorate Identifier 2011-SW-055-AD; Amendment 39-17020; AD 2011-18-52]

#### Airworthiness Directives; Agusta S.p.A. Helicopters

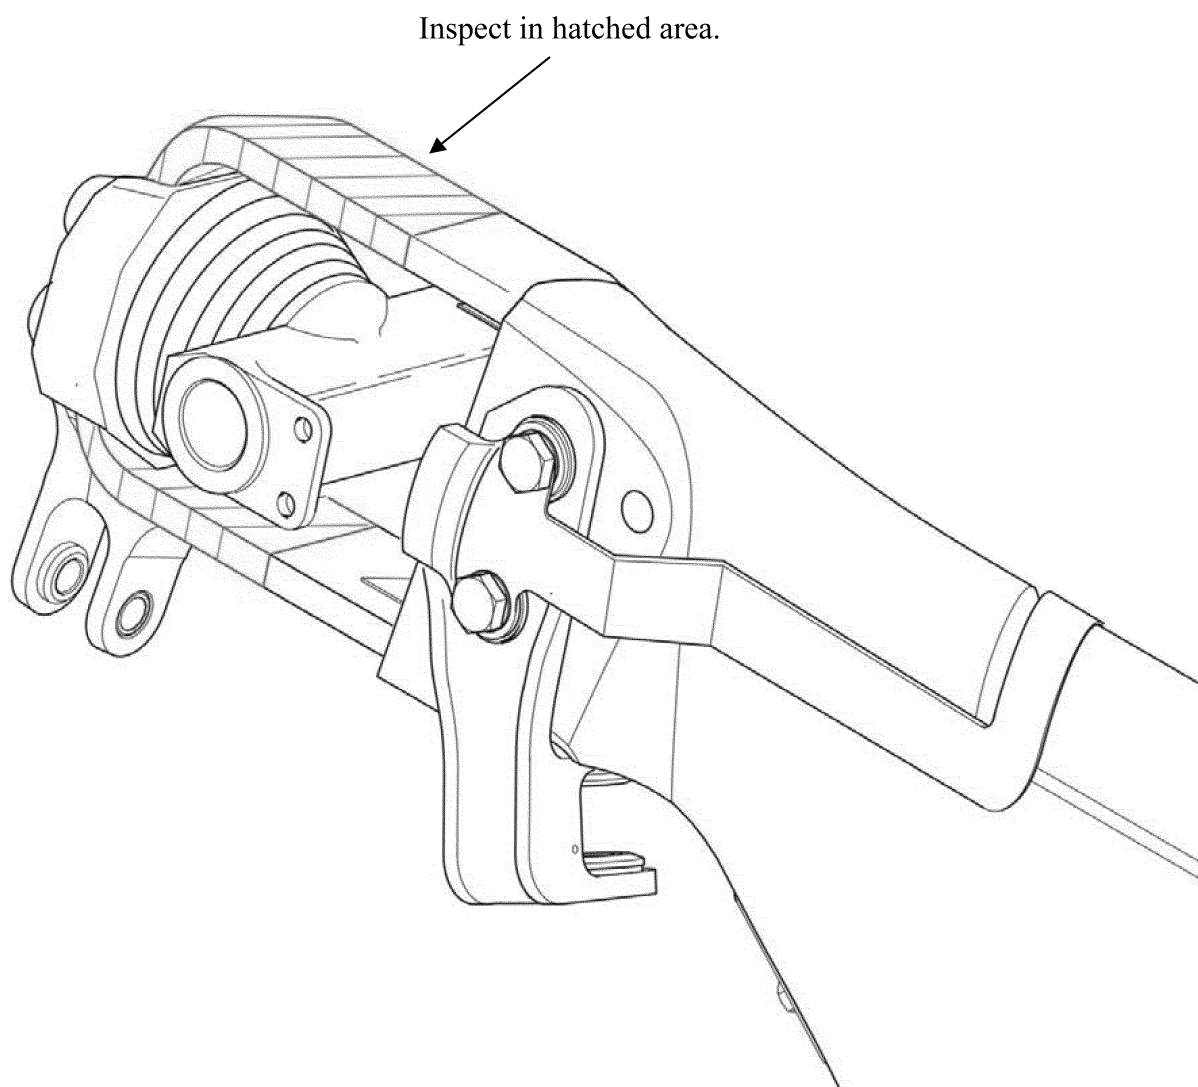
This AD defines the unsafe condition as cracks in a T/R blade. The actions in this AD are intended to detect and prevent a crack in a T/R blade which could lead to failure of a T/R blade and subsequent loss of control of the helicopter.

(3) Within 25 hours TIS, and thereafter at intervals not to exceed 25 hours TIS, visually inspect the T/R blade for a crack or damage that exceeds the limits of the applicable maintenance manual. Inspect in the area depicted in the following figure using a mirror, magnifying glass (5X or greater), and light source, or borescope.

(4) If there is a crack, or if there is damage that exceeds the limits of the applicable maintenance manual, before further flight, replace the T/R blade with an airworthy T/R blade.
