[Docket No. FAA–2008–0101; Directorate Identifier 2007–SW–76–AD; Amendment 39–15357; AD 2007–26–51]

#### **Airworthiness Directives; Eurocopter Deutschland GmbH Model EC135 Helicopters**

**SUMMARY:** This document publishes in the **Federal Register** an amendment adopting Airworthiness Directive (AD) 2007–26–51, which was sent previously to all known U.S. owners and operators of Eurocopter Deutschland GmbH (Eurocopter) Model EC135 helicopters by individual letters. This AD requires, within 5 hours time-in-service (TIS), inspecting the tail rotor control rod (control rod) and adjoining ball pivot and replacing any unairworthy parts before further flight. This amendment is prompted by a report of a fatal accident involving the failure of a control rod. The actions specified by this AD are intended to prevent failure of a control rod and subsequent loss of control of the helicopter.

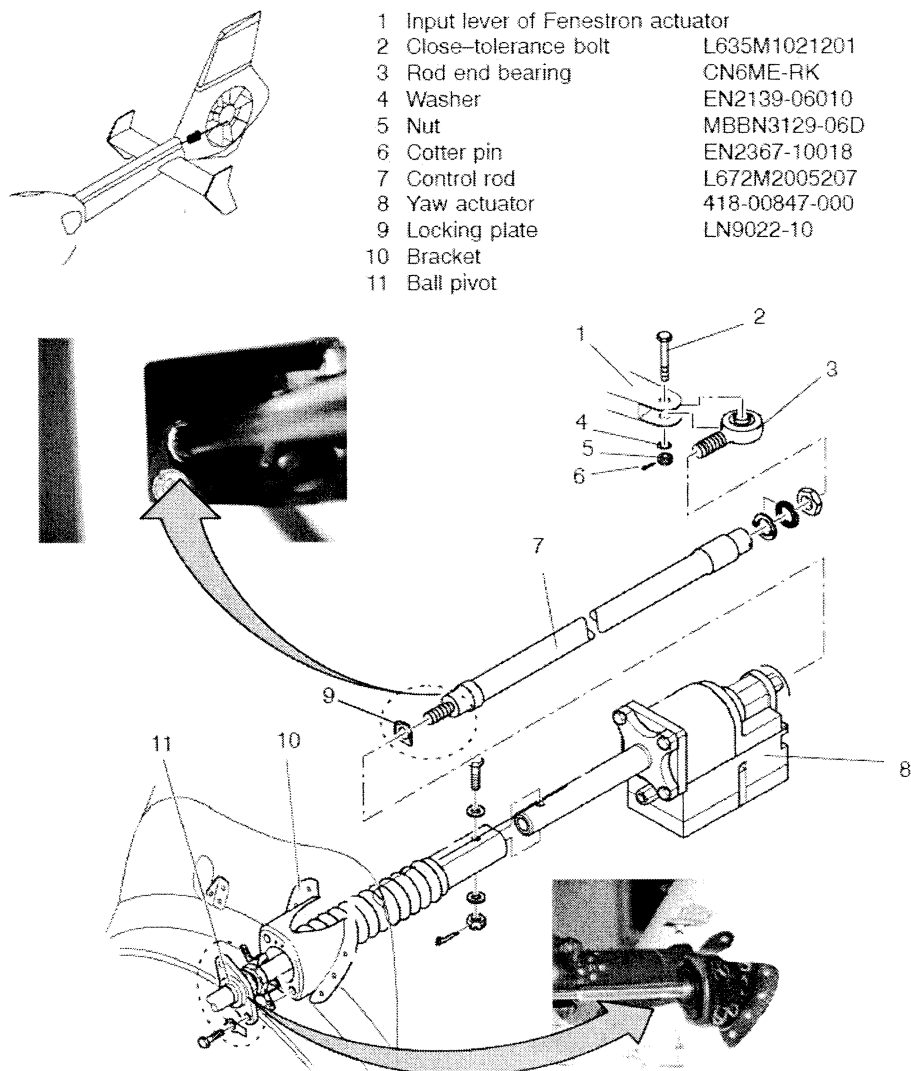
Ball Pivot and Control Rod  
Figure 1

(a) Within 5 hours time-in-service (TIS), inspect the control rod, shown in item 7, Figure 1, of this AD, with the parts identified in parenthesis as follows:

(1) Pull the control rod (7) until it reaches its stop position. Inspect attachment hardware of control rod (7) for a tight fit. Manually inspect for possible relative motion between control rod (7) and yaw actuator (8).

(2) Inspect the locking plate (9) for a tight fit.

(b) Inspect the ball pivot as shown in item 11, Figure 1, of this AD by removing the tail rotor drive shaft fairing and inspecting for a loose bearing or play. If a loose bearing or play is found, before further flight, replace the ball pivot with an airworthy ball pivot.

(3) Visually inspect the attachment hardware between control rod (7) and yaw actuator (8) for play or thread exposure. If play or thread exposure is found, before further flight, replace the control rod with an airworthy control rod.
