Federal Register

Monday, May 6, 2013

[Docket No. FAA-2011-1231; Directorate Identifier 2011-NM-088-AD; Amendment 39-17418; AD 2013-08-01]

Airworthiness Directives; The Boeing Company Airplanes

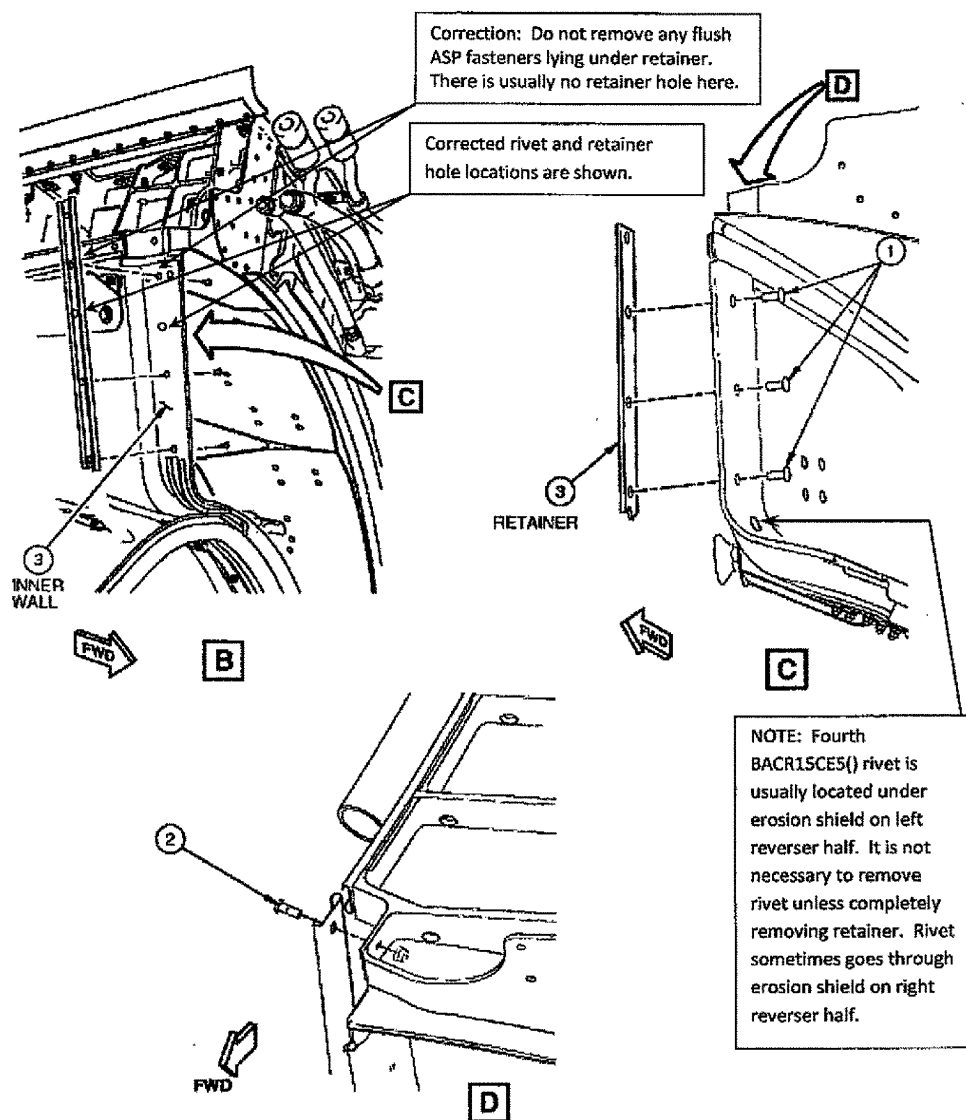
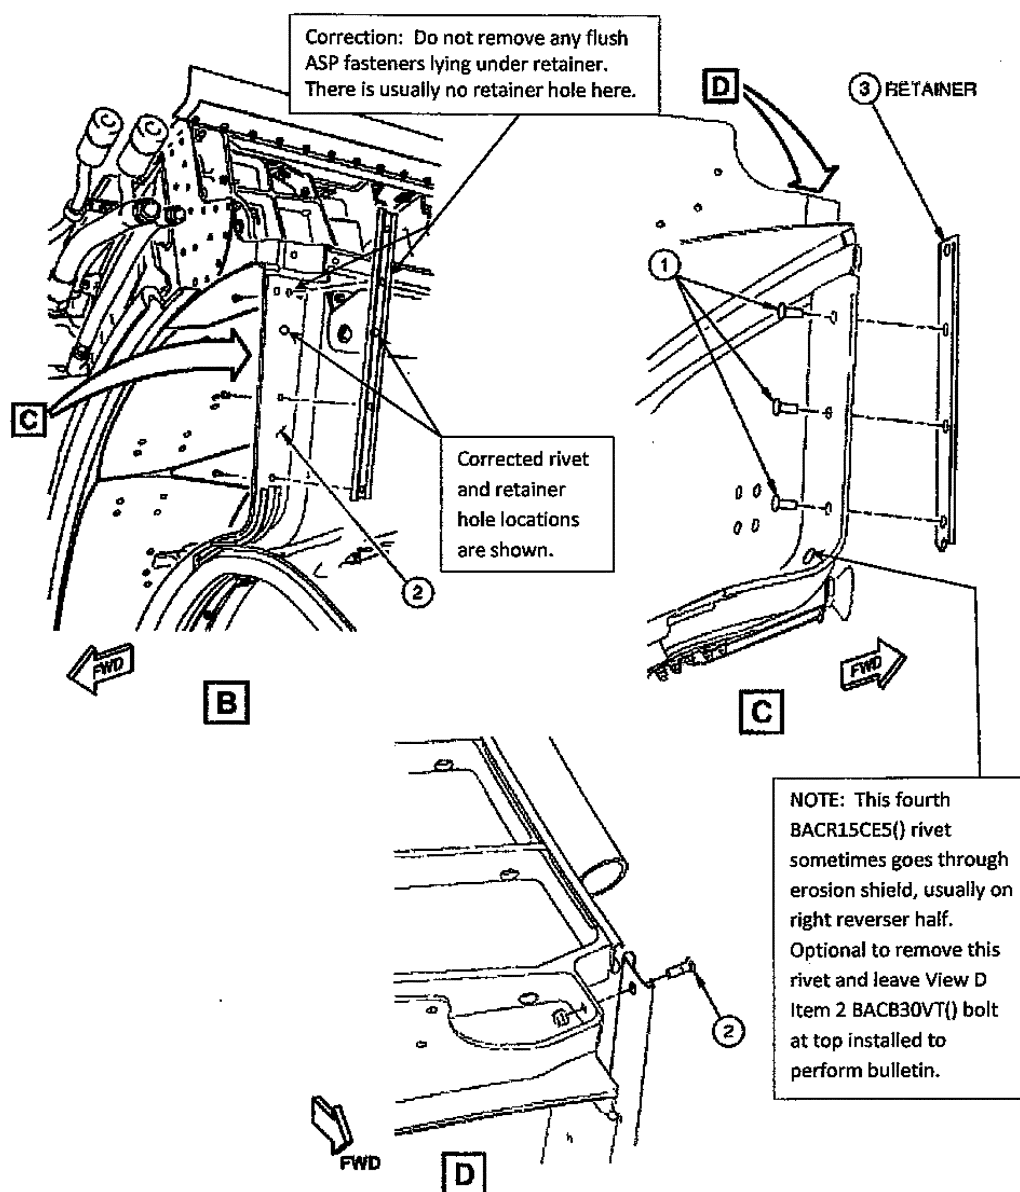
(2) Figures 1 and 3 of this AD, titled “Fastener Removal of the Retainer Support on the Left (Right) Thrust Reverser Half,” have View B showing the top fastener in the center of three adjustable sustained preload (ASP) fasteners. That top fastener does not require removal in order to remove the retainer. The figures in this AD point to the correct information for those fasteners.

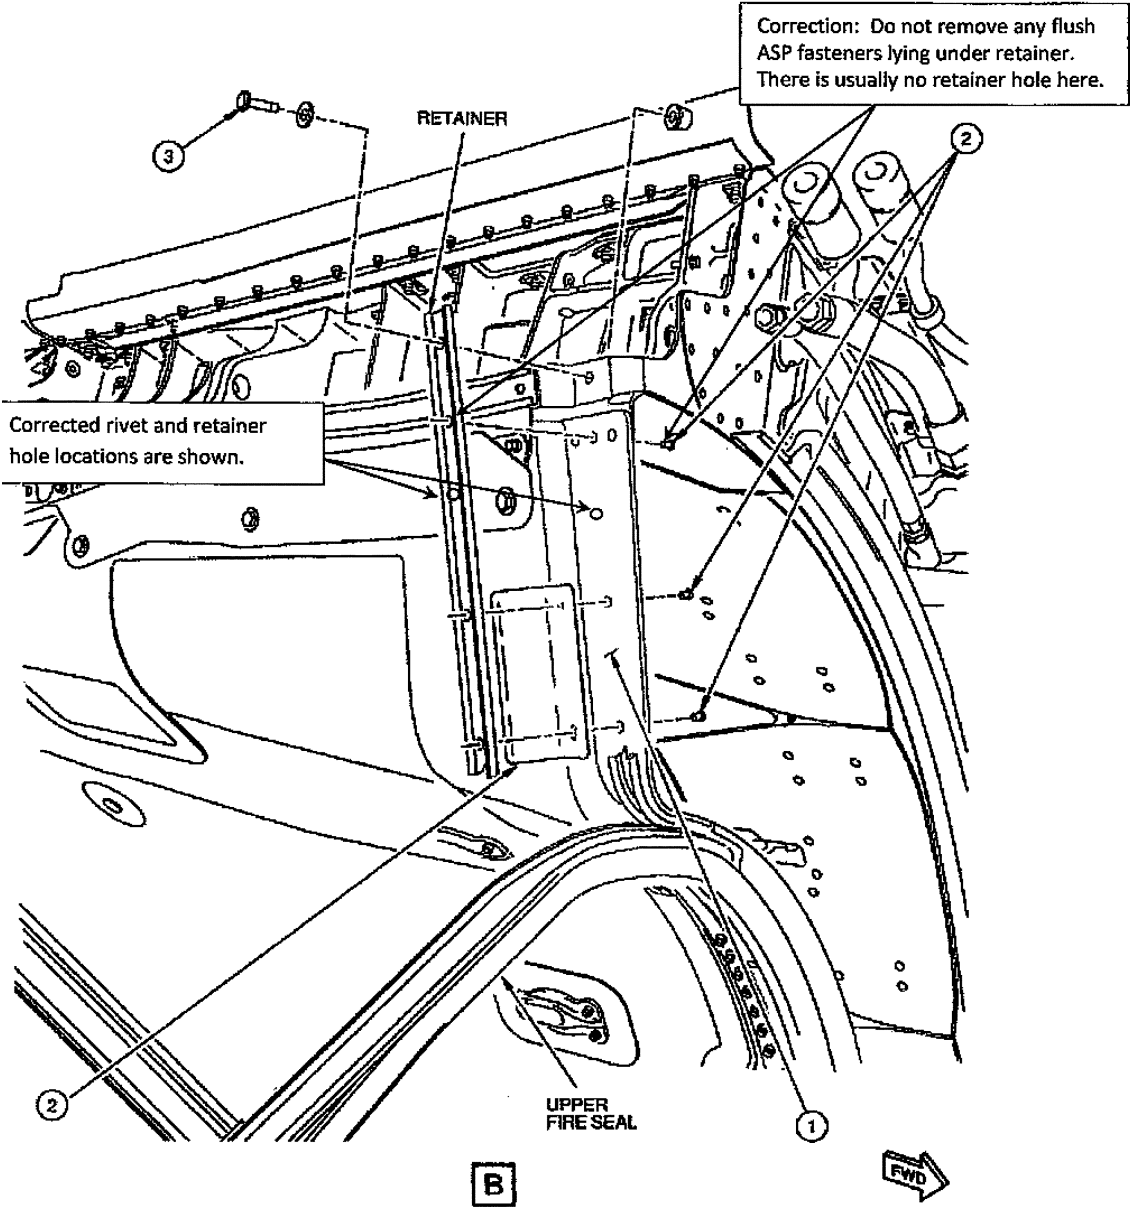
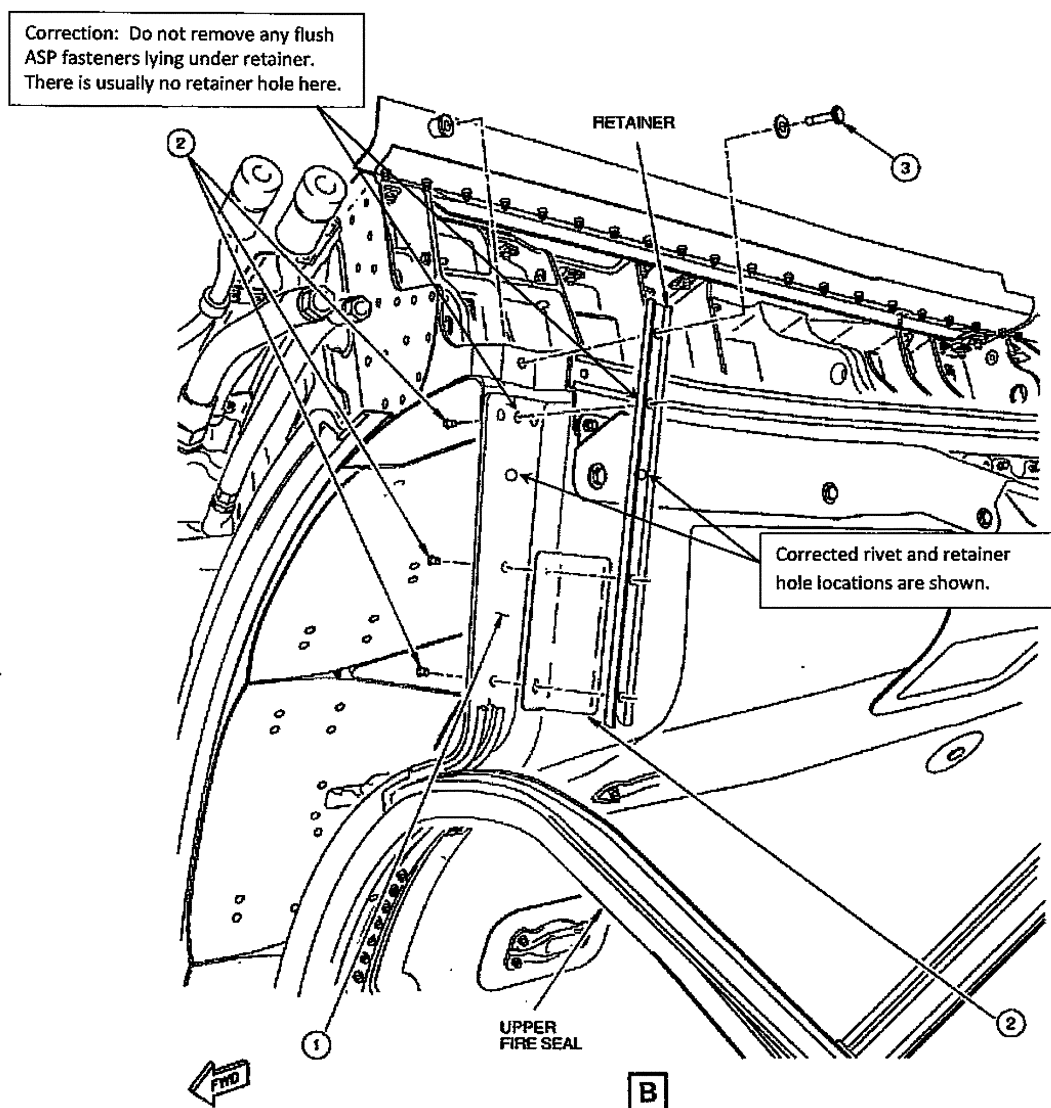
(3) Figures 2 and 4 of this AD, titled “Installation of the New Bracket behind the Retainer Support on the Left (Right) Thrust Reverser Half,” have View B showing the top rivet hole. That rivet hole is actually below the row of three ASP fasteners. The figures in this AD point to the correct information for those rivet holes.
