Airworthiness Directives; Eurocopter France Helicopters

SUMMARY: We propose to adopt a new airworthiness directive (AD) for Eurocopter France Model AS350B, AS350BA, AS350B1, AS350B2, AS350B3, AS350C, AS350D, AS350D1, AS355E, AS355F, AS355F1, AS355F2, AS355N, and AS355NP helicopters with certain Aerazur emergency flotation gear attachment brackets (brackets) installed. This proposed AD would require an initial and recurring inspection of the brackets for a crack, and if there is a crack, replacing the cracked bracket with an airworthy bracket. This proposed AD is prompted by reports of cracks on the brackets. The proposed actions are intended to prevent failure of the emergency flotation system and loss of float stability in the event of a water landing.

Eurocopter France: Docket No. FAA-2012-0631; Directorate Identifier 2011-SW-021-AD.

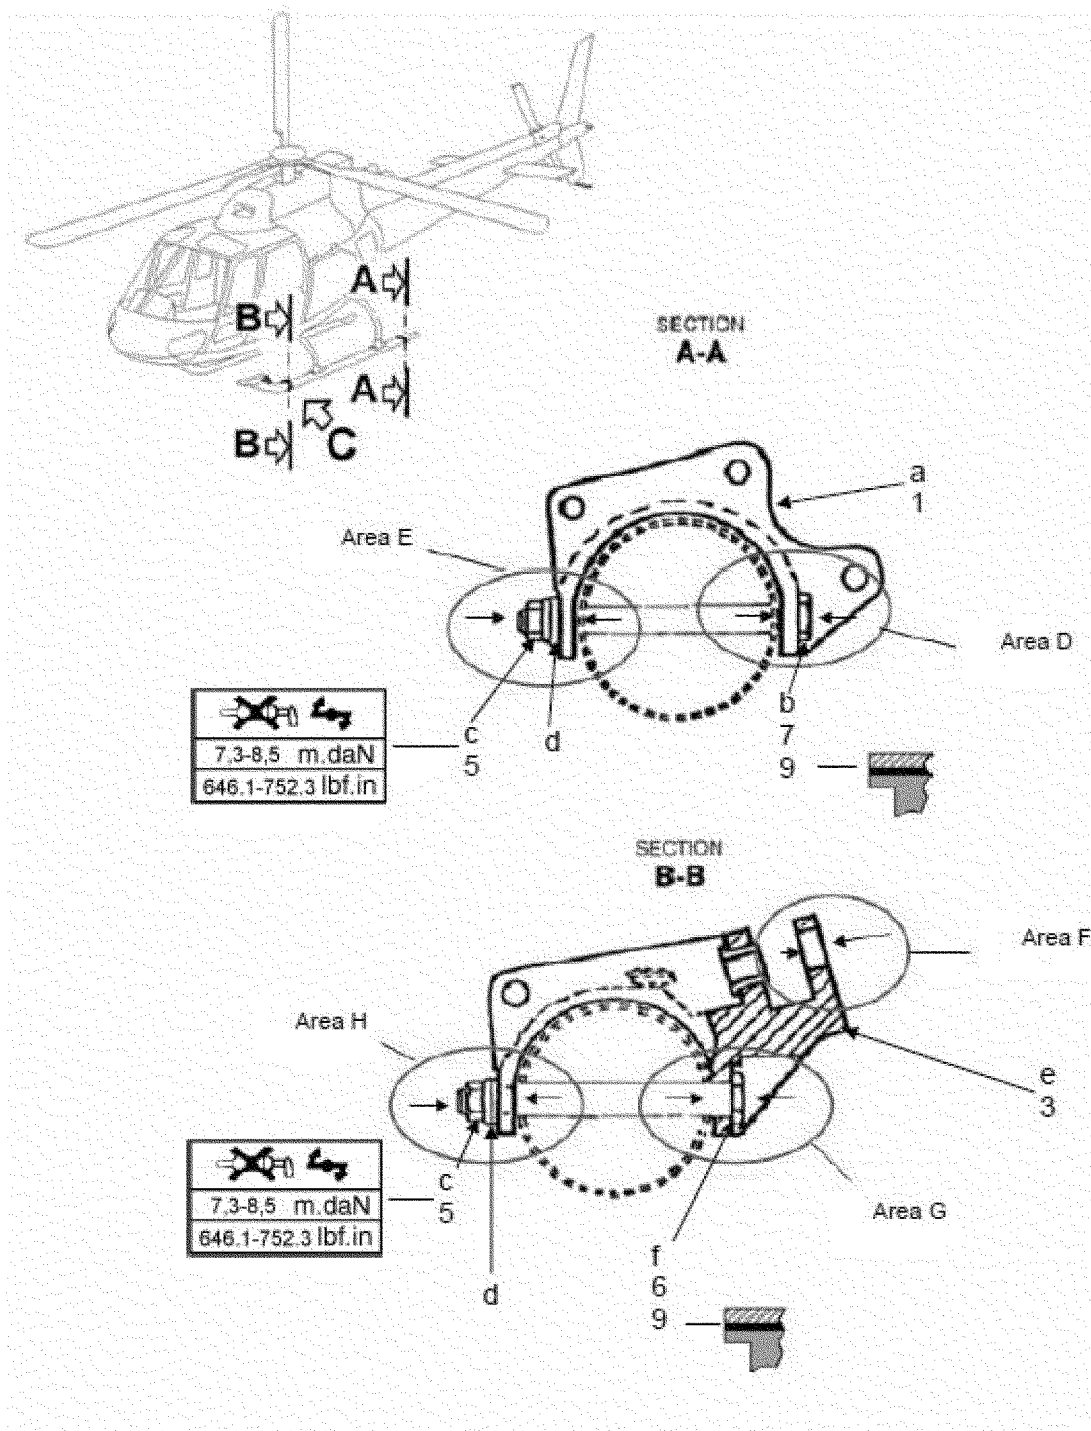
Figure 1. Emergency Flotation Gear Attachment Brackets

This AD defines the unsafe condition as a crack in an attachment bracket of the emergency flotation gear. This condition could result in failure of the emergency flotation system and loss of float stability in the event of a water landing.

- (1) Using a 5x or higher power magnifying glass, visually inspect the front emergency flotation gear attachment bracket (Figure 1 of this AD, section B-B, item (e)) in Areas F, G, and H; and the rear emergency flotation gear attachment bracket (Figure 1 of this AD, section A-A, item (a)) in Areas D and E for a crack.

(2) If there is a crack, replace the cracked emergency flotation gear attachment bracket with an airworthy emergency flotation gear attachment bracket prior to reinstallation of the emergency flotation equipment.
