[Docket No. 2001-SW-13-AD]

Airworthiness Directives; Bell Helicopter Textron, Inc. Model 47B, 47B-3, 47D, 47D-1, 47G, 47G-2, 47G2A, 47G-2A-1, 47G-3, 47G-3B, 47G-3B-1, 47G-3B-2, 47G-3B-2A, 47G-4, 47G-4A, 47G-5, 47G-5A, 47H-1, 47J, 47J-2, 47J-2A, and 47K Helicopters

ACTION: Notice of proposed rulemaking.

Bell Helicopter Textron, Inc.: Docket No. 2001-SW-13-AD. Supersedes AD 2000-18-51, Amendment 39-11983, Docket No. 2000-SW-35-AD.

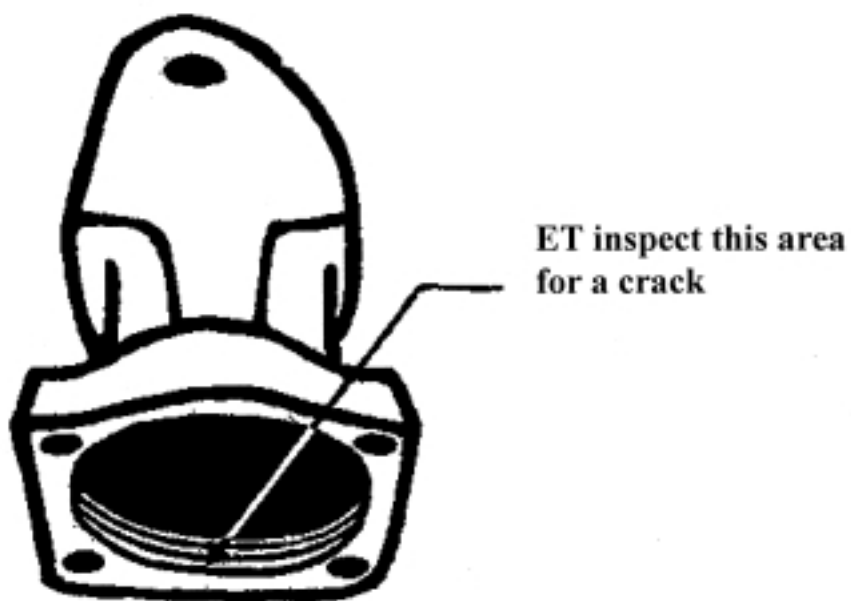
Figure 1, Appendix 1

1.1 The inboard inside diameter machined threads (reference figure 1).

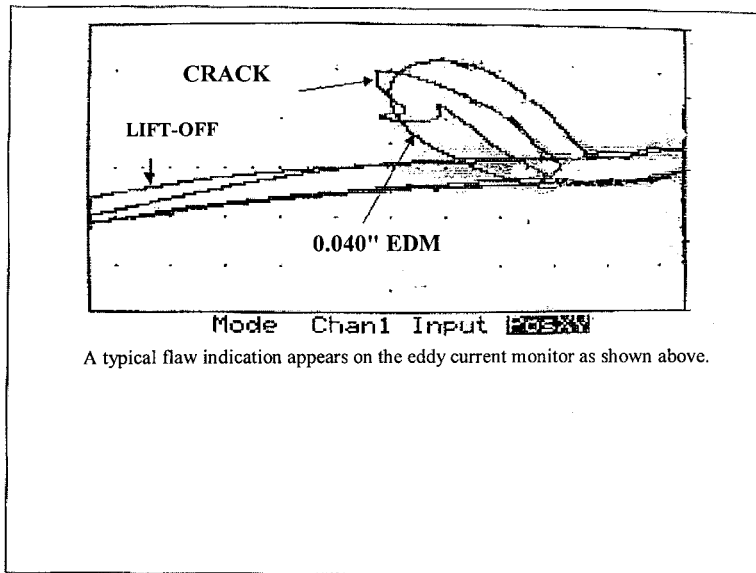
Figure 2, Appendix 1

6.1 Place the probe into the threaded area and slide it in the same direction as was done on the standard while monitoring the screen for root cracks. Moving the probe in the same direction produces a repeatable display that allows for more accurate flaw size determination. Scan the probe along each individual thread until all the threads are inspected. (See Figures 2 and 3.)

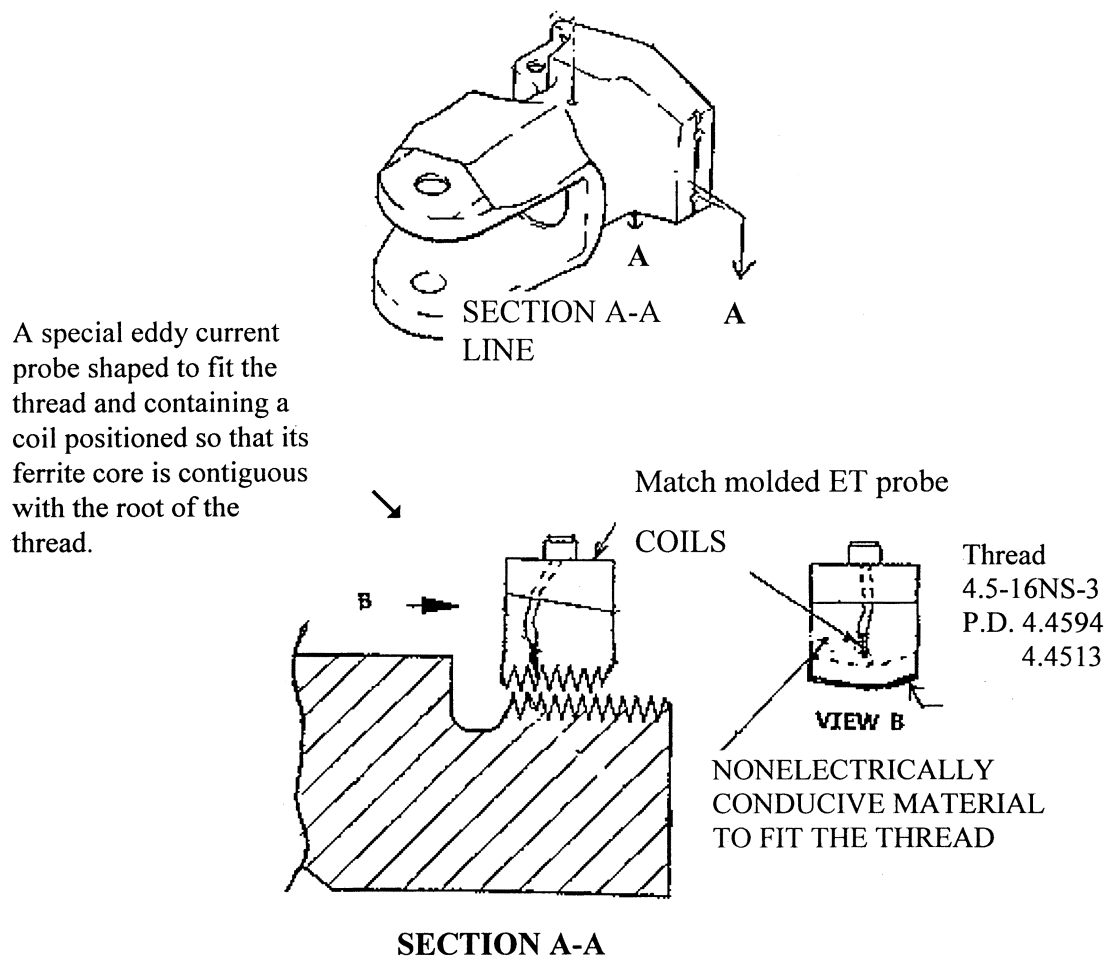
Figure 3, Appendix 1

2.2 Match molded ET probe SPC-193 (100kHz) or equivalent. (See Figure 3.)

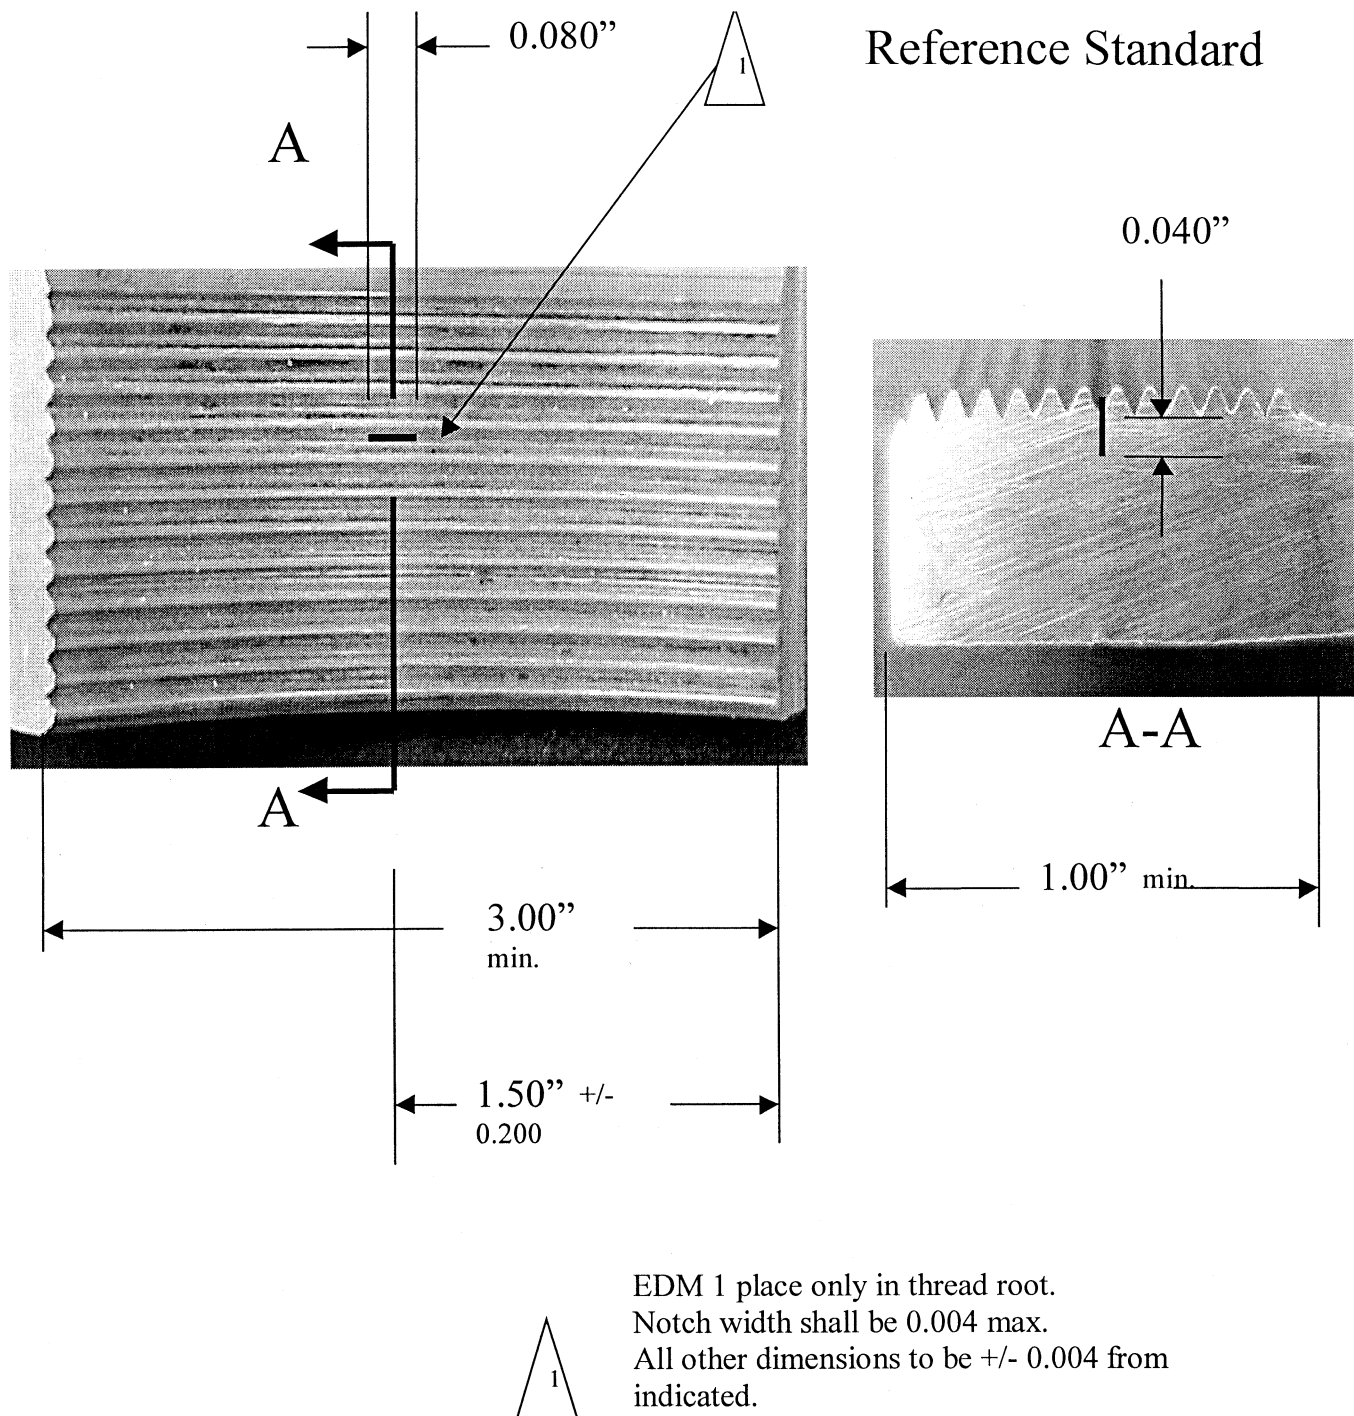
Figure 4, Appendix 1

2.3 Reference standard EC-010-021, or equivalent. (See Figures 4 and 5.)

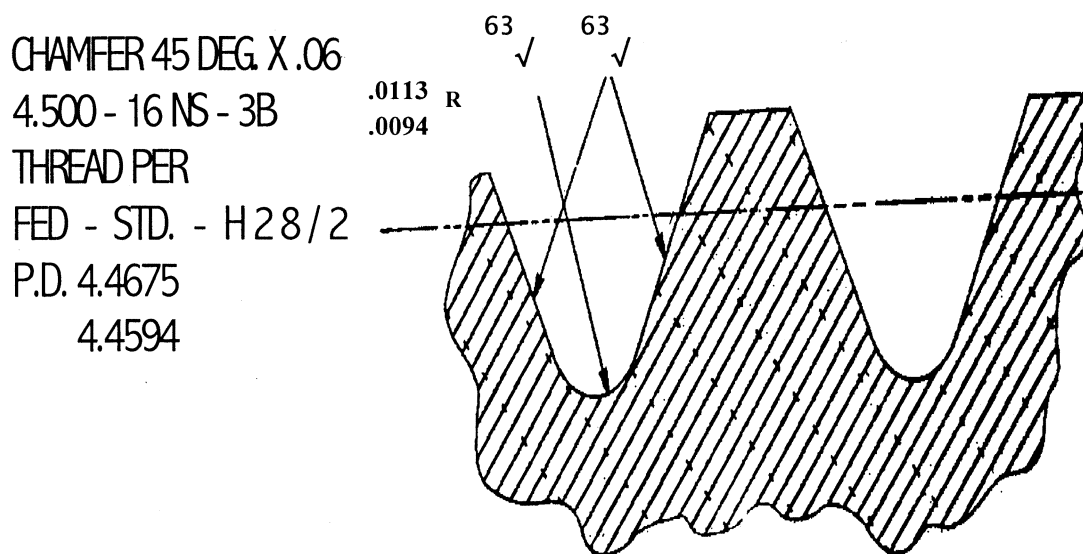
Figure 5, Appendix 1

1. Standard may be machined from aluminum tube stock.
2. The standard shall contain a minimum of four teeth per the tooth dimensions specified.
3. The EDM notch shall be placed in the center most tooth root as measured across the width of the standards. There shall be no less than two teeth and one root on either side of the EDM notch.
