[Docket No. FAA-2018-0454; Product Identifier 2017-NM-056-AD]

Airworthiness Directives; Airbus Airplanes

ACTION: Notice of proposed rulemaking (NPRM).

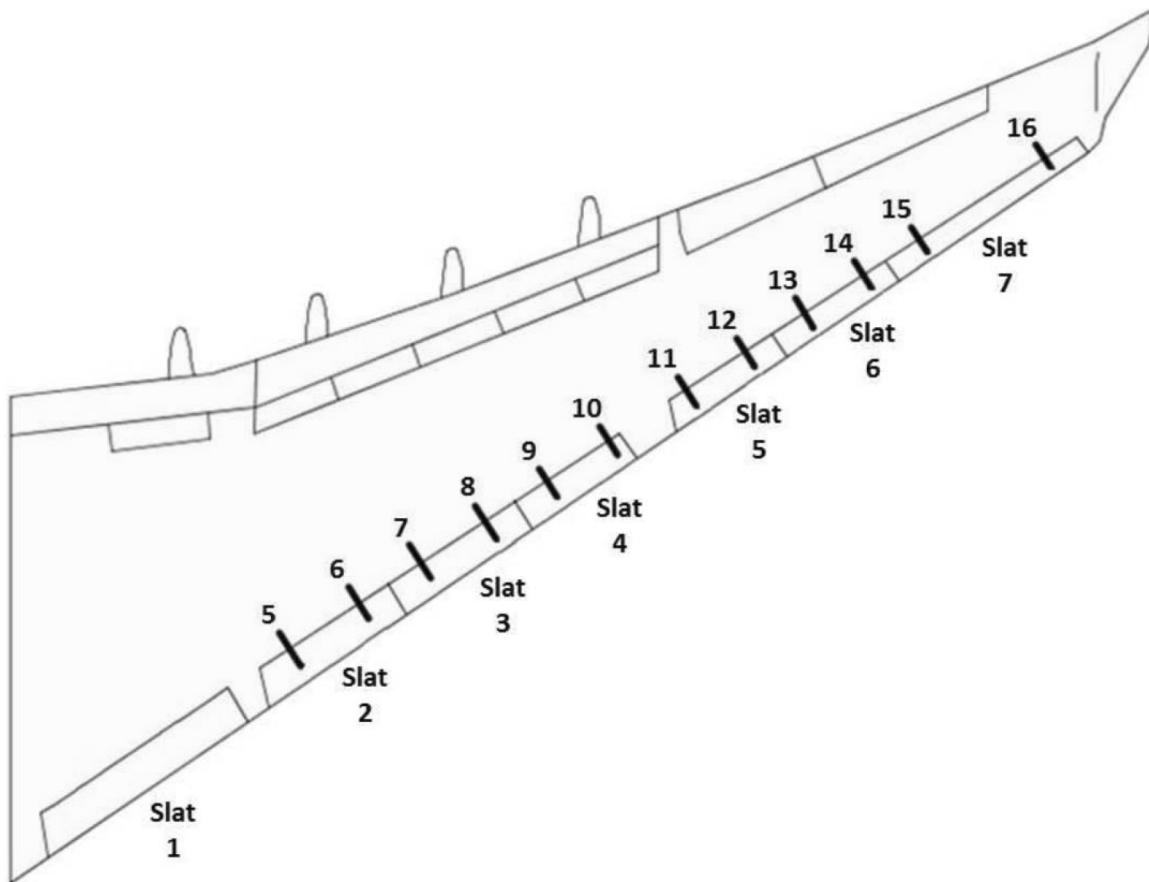
Figure 1 to paragraph (g) of this AD – Positions of Affected Slat Tracks

(1) For the purpose of this AD, “affected slat track” is defined as a pre-modification 45967 slat track, located at the wing positions as indicated in figure 1 to paragraph (g) of this AD, and having a part number specified in figure 2 to paragraph (g) of this AD. In case the part number identification (ID) plate is missing or cannot be read, the slat track can be identified by the ink marking. If the
