Airworthiness Directives; Bell **Helicopter Textron Canada Model 206L Series Helicopters**

SUMMARY: This document proposes adopting a new airworthiness directive (AD) for the Bell Helicopter Textron Canada (BHTC) Model 206L series helicopters. This proposal would require inspecting the fuel low-level detector switch unit (switch unit) to determine if it is a certain serialnumbered switch unit that may fail to indicate a low fuel condition. If the serial number is missing or unreadable, the mounting flange of the switch unit is not colored red or the purchase date is within a certain range or cannot be determined, this proposal would require an operational test. The AD would also require replacing before further flight each affected switch unit with an airworthy switch unit that is not listed in the applicability of the AD. This proposal is prompted by the manufacturer's discovery that eight switch units may have a manufacturing flaw that could cause them to hang in the high position and fail to indicate a low fuel condition. The actions specified by this proposed AD are intended to prevent failure of the switch unit to indicate a low fuel condition that could lead to fuel exhausti

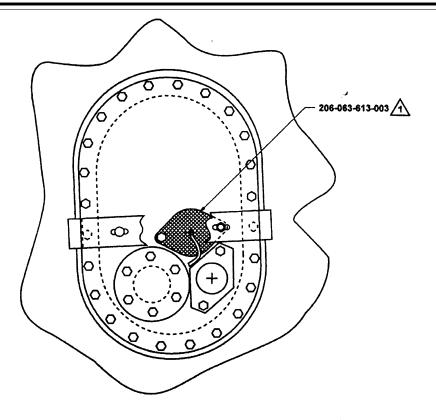
Part number and serial number are located in the cross hatched area.

(a) On or before the next 100-hour time-inservice inspection, determine whether the installed switch unit has a serial number listed in the applicability section of this AD. If the installed switch unit is one of the listed switch units, before further flight, replace it with an airworthy switch unit that has a serial number other than those listed in the applicability section of this AD. See Figure 1 of this AD for the location of the serial number.
