[Docket No. FAA-2010-0342; Directorate Identifier 2002-NE-08-AD; Amendment 39-16458; AD 2010-20-23]

Airworthiness Directives; Bombardier-Rotax GmbH Type 912 F, 912 S, and 914 F Series Reciprocating Engines

ACTION: Final rule.

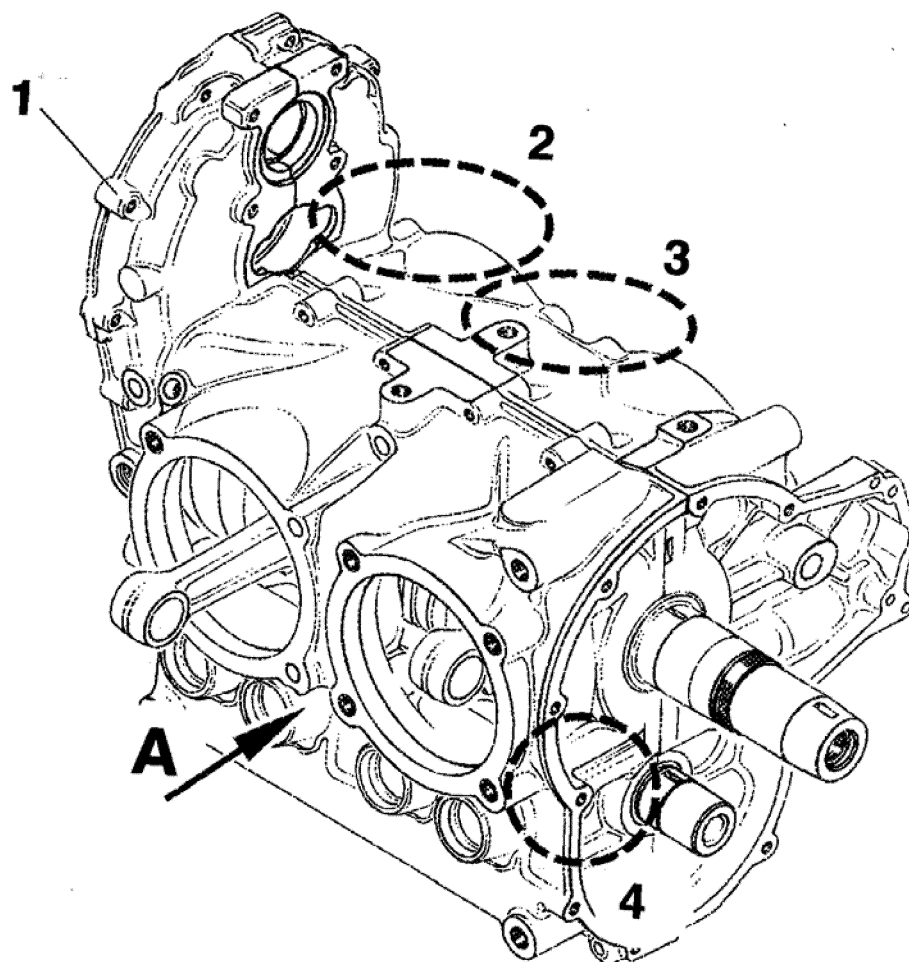
Figure 1. Engine Crankcase Inspection Areas

(1) Inspect the engine crankcase (item 1, Figure 1 of this AD) for cracks especially in the area of cylinder 1 upper side (item 2), between cylinder 1 and 3 upper side (item 3), cylinder 4 lower-right side (item 4) and detailed inspection in the area identified in Figure 2 (item 5) of this AD. Information concerning this inspection can be found in Bombardier-Rotax Mandatory Service Bulletins No. SB–912–029, Revision 3, dated July 11, 2006 and No. SB–914–018, Revision 3, dated July 11, 2006.

(2) Cracks in crankcases of engines with a ROTAX cooling air baffle may not be easily visible, and oil leaks may be an indication of cracks. Visually inspect for oil leaks in areas of cylinder 1 upper side (item 2, Figure 1 of this AD) and between cylinder 1 and cylinder 3 upper side (item 3).

(4) If the engine crankcase is cracked, remove the engine from service before further flight.

(h) Visually inspect the engine crankcase (item 1, Figure 1 of this AD) for cracks at each 100-hour, annual, or progressive inspection, or within 110 hours TIS since last inspection, whichever occurs first, in accordance with paragraphs (g)(1) through (g)(4) of this AD.
