[Docket No. 2000-SW-13-AD; Amendment 39-12132; AD 2001-04-13]

#### Airworthiness Directives; Eurocopter France Model SA.315B, SA.316B, SA.316C, SE.3160, and SA.319B Helicopters

##### 2001-04-13 Eurocopter France:

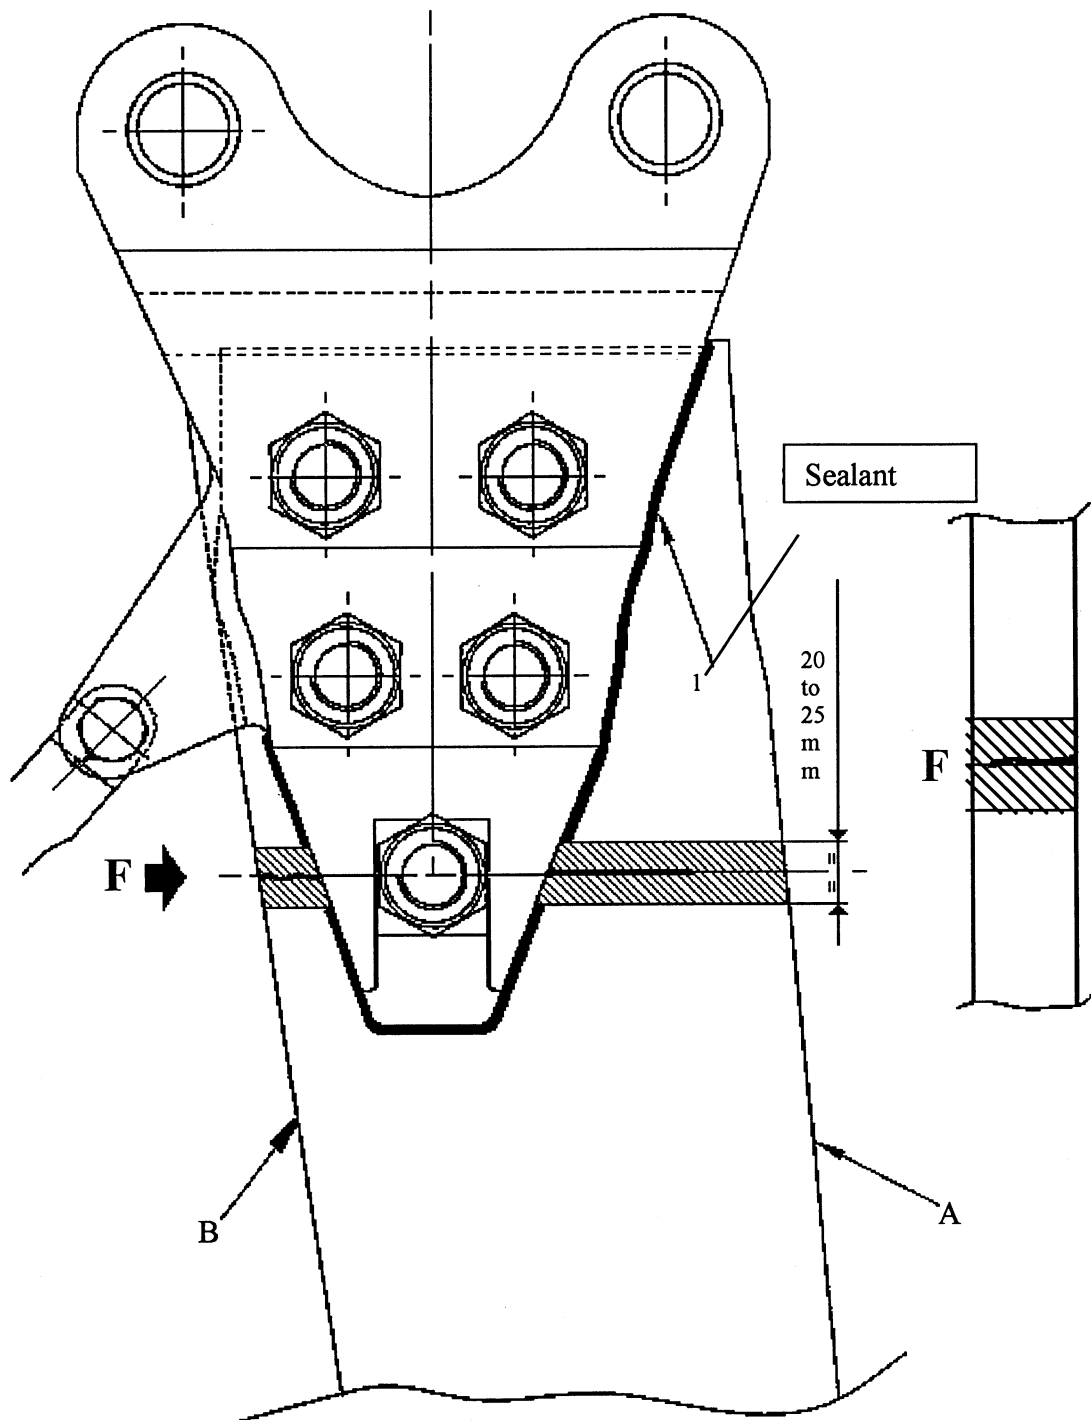
Figure 1

(iii) By either a dye penetrant or eddy current method, inspect each blade along the hatched area indicated in Figure 1, beginning on the blade lower surface, then on the flat section of the trailing edge (B), on the blade upper surface, and then on the flat section of the leading edge (A).

(iv) If a crack is found, replace the blade with an airworthy blade before further flight.

(2) Ensure that there is a sealant bead (1) around the edge of each blade cuff. If no sealant bead exists or if a sealant bead shows excessive wear, before further flight, apply a sealant bead in accordance with paragraph 2.2 of the Accomplishment Instructions of Eurocopter France SB 65.137 R1, dated November 17, 1993.
