Federal Aviation Administration

[Docket No. FAA-2006-25105; Directorate Identifier 2006-CE-33-AD; Amendment 39-14982; AD 2007-06-01]

Airworthiness Directives; Raytheon Aircraft Company Beech Models 45 (YT-34), A45 (T-34A, B-45), and D45 (T-34B) Airplanes

ACTION: Final rule.

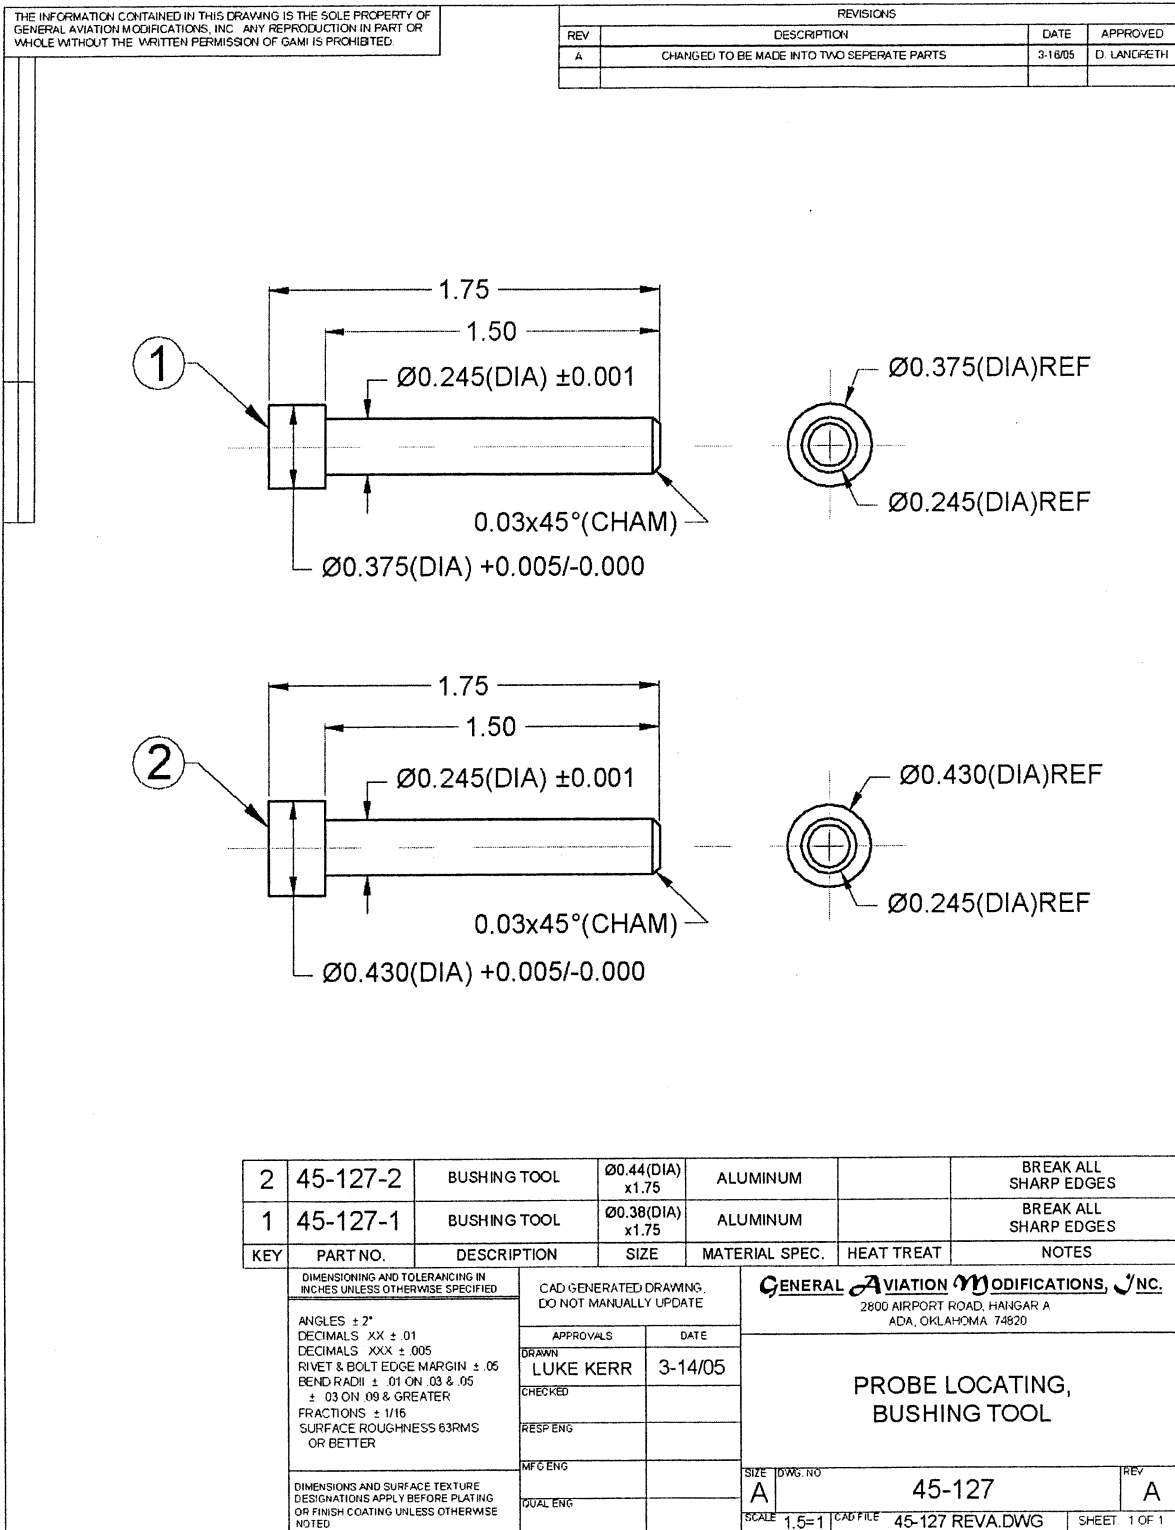
Figure 1

Frequency-350 KHz, Gain Vertical-75 dB, Horizontal-69 dB, Drive-Mid, Filters- Lo Pass-30, Hi Pass-0, Lift off-Horizontal to the left, adjust as required. The most reliable indication (minimum of 1 1/2 to 2 gratitudes) of the smallest observable flaw in the coupon (see the attached Figures) occurs from the notch extending 0.025" past the edge of the nominal fastener head (total notch length of 0.100" from the edge of the nominal hole). Install appropriate aluminum guide pin into bushing such that the edge of the guide pin is flush with the edge of the bushing. Using the pin (see the attached Figures) as a guide, circle the area surrounding the steel bushing with the probe and adjacent area (approximately 1/4") to inspect for cracks. Inspect forward and aft surfaces surrounding bushings of each spar.
