[Docket No. FAA–2010–1013; Directorate Identifier 2010–CE–048–AD; Amendment 39–16478; AD 2010–21–18]

Airworthiness Directives; Cessna Aircraft Company (Cessna) Models 336, 337, 337A (USAF 02B), 337B, M337B (USAF 02A), T337B, 337C, T337C, 337D, T337D, 337E, T337E, 337F, T337F, 337G, T337G, 337H, P337H, T337H, T337H–SP, F337E, FT337E, F337F, FT337F, F337G, FT337GP, F337H, and FT337HP Airplanes

2010–21–18 Cessna Aircraft Company: Amendment 39–16478; Docket No. FAA–2010–1013; Directorate Identifier 2010–CE–048–AD.

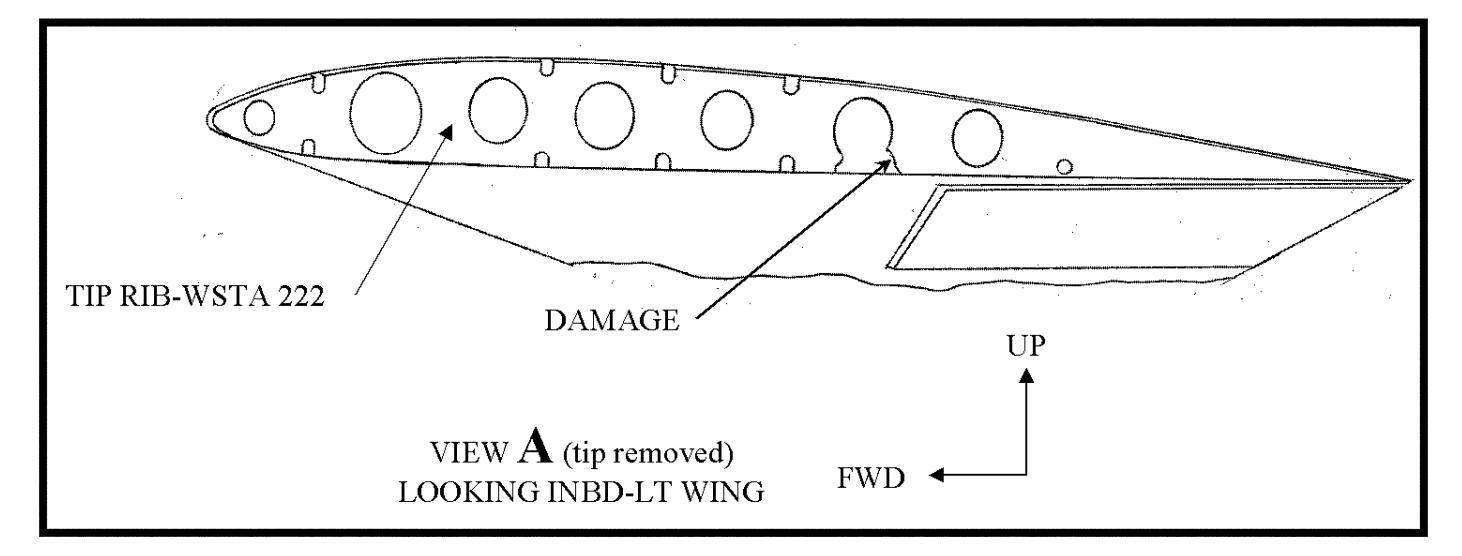
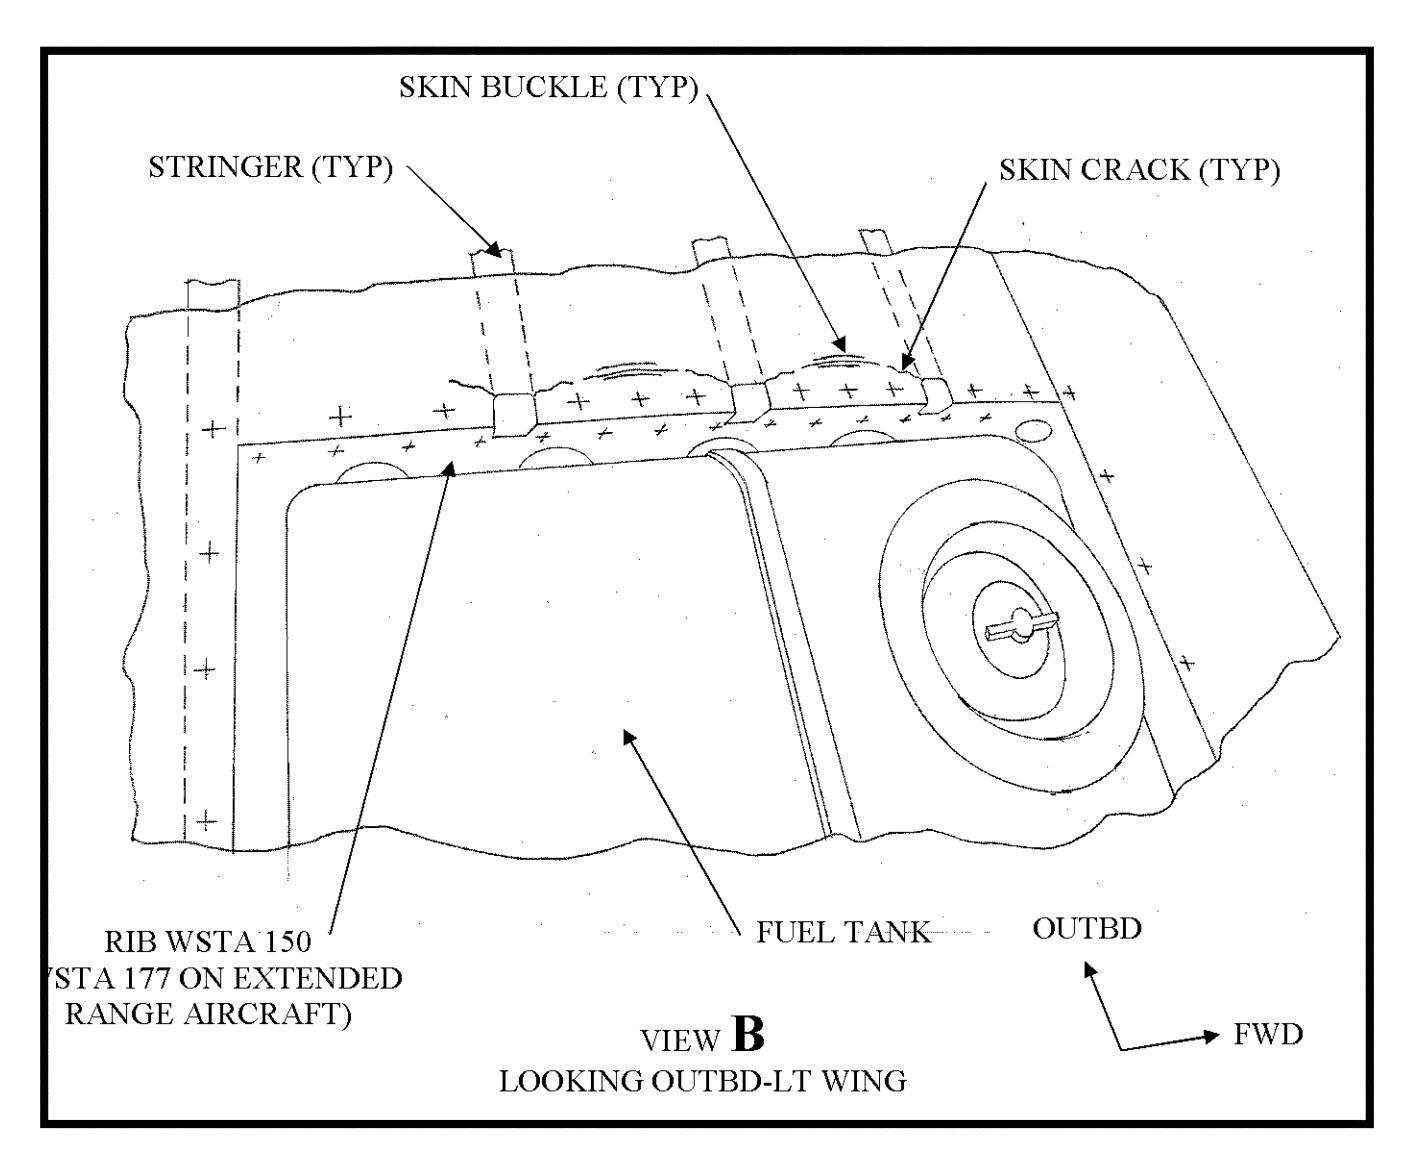
(11) Inspect rib at WSTA 222 for damage. Trimming of the rib may have been done to allow installation of fuel lines (*See* View A, Figure 2). Repair in accordance with AC 43.13–1B, Chapter 4, paragraph 4–58(g) and Figure 4–14, or by using another FAAapproved method that restores equivalent strength of the wing rib.

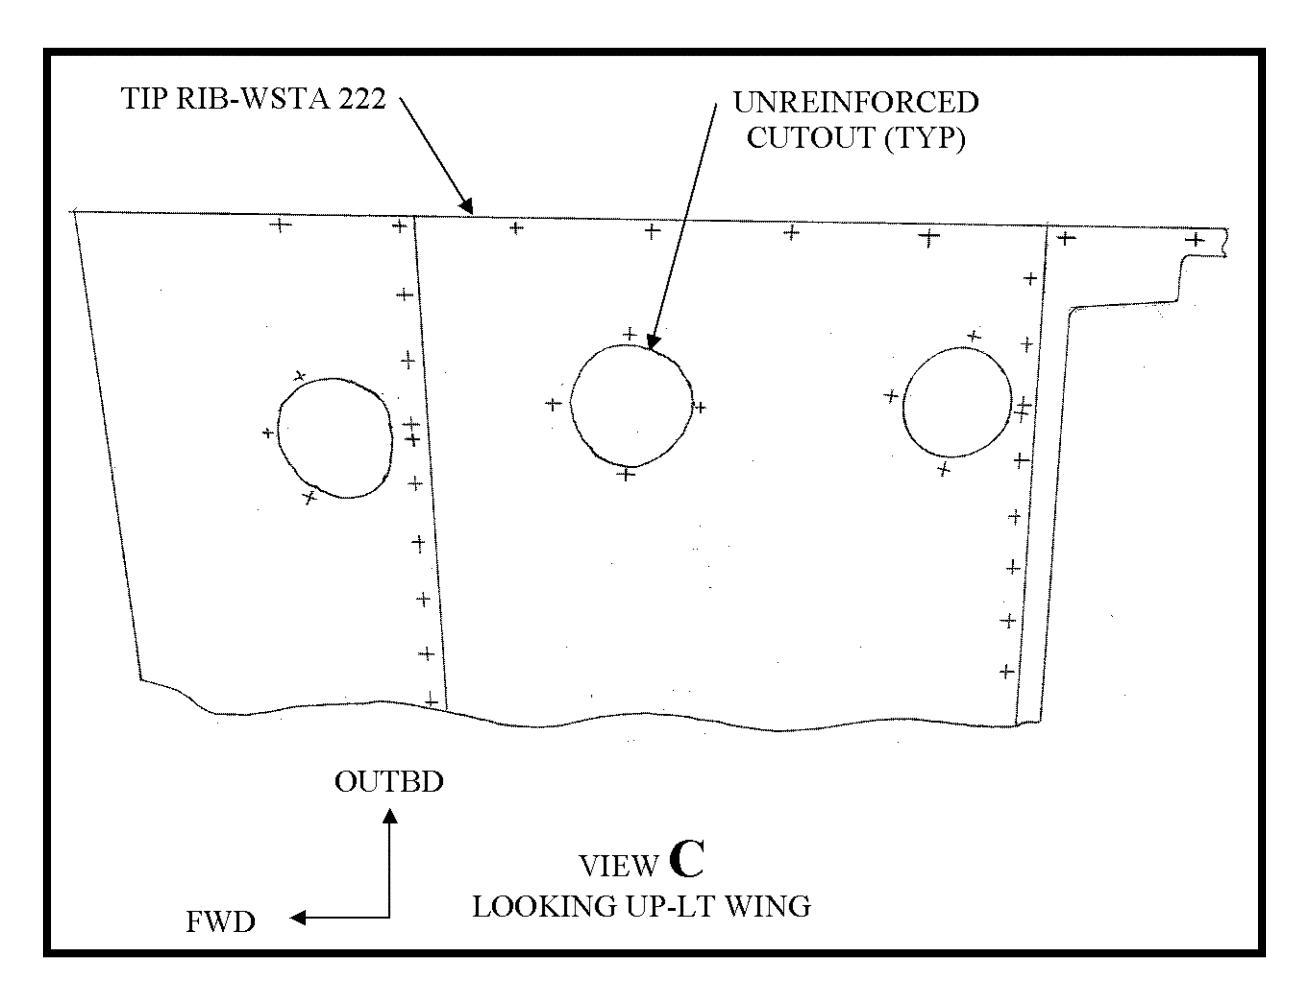
Figure 3

Focused inspection items to look for: (1) Wrinkles in upper wing skins, from the outboard edge on the fuel tank access covers (WSTA 150 or 177) to the WSTA 222 (*See* View B, Figure 3).

(3) Cracking of the upper wing skins. Pay particular attention to any wrinkles, the radius between stiffeners at WSTA 150 (under fuel tank covers), and unreinforced access holes (*See* View B, Figure 3).

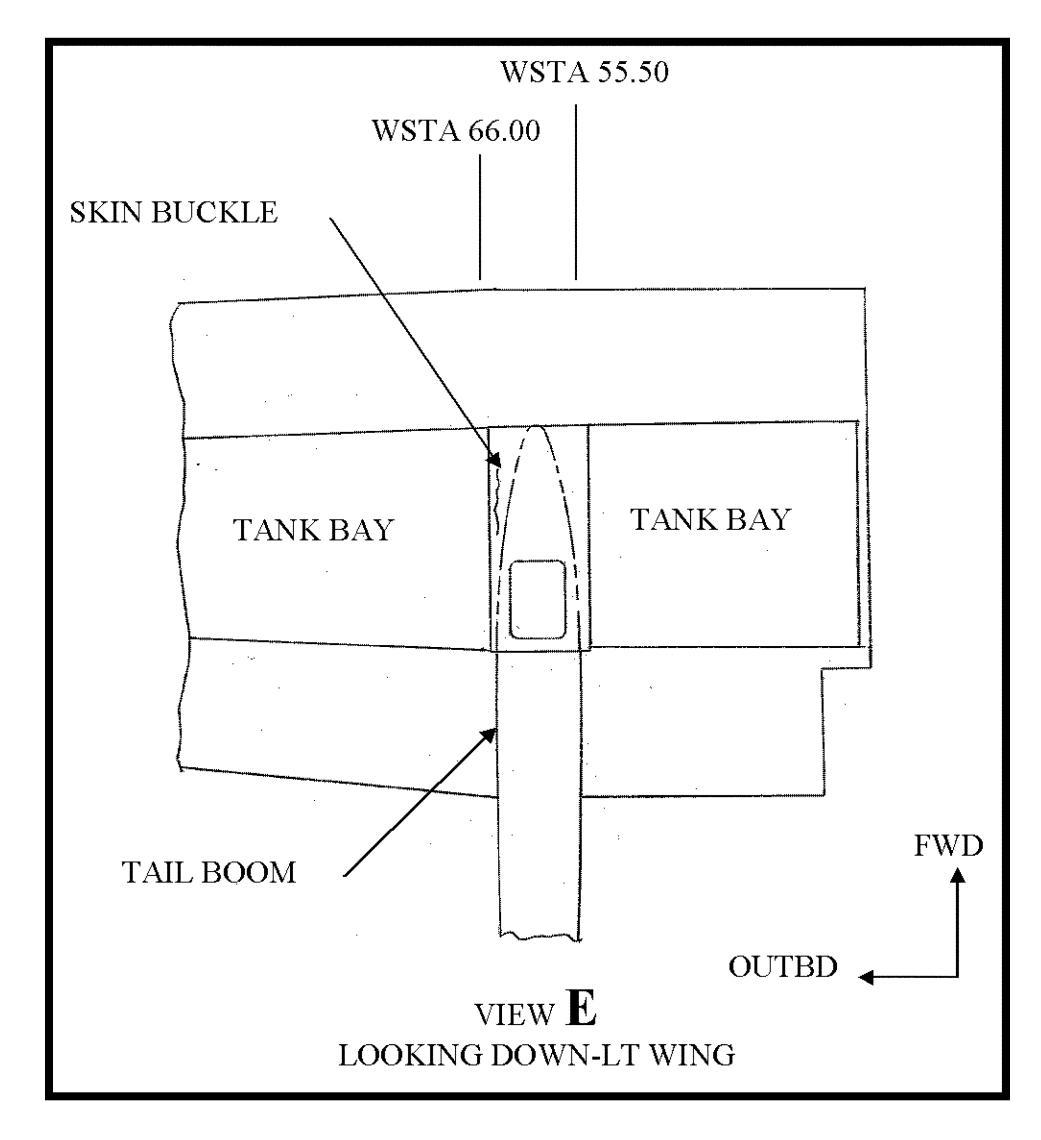
Figure 5

(3) Inspect the upper spar cap horizontal flanges for open holes (*See* View D, Figure 5). BILLING CODE 4910–13–P
