FIGURE 1- HEATING LOAD HOURS (HLH) FOR THE UNITED STATES

10.11 *Average annual electrical standby mode and off mode energy consumption.* Calculate the annual electrical standby mode and off mode energy consumption (E_{SO}) in kilowatt-hours, defined as:

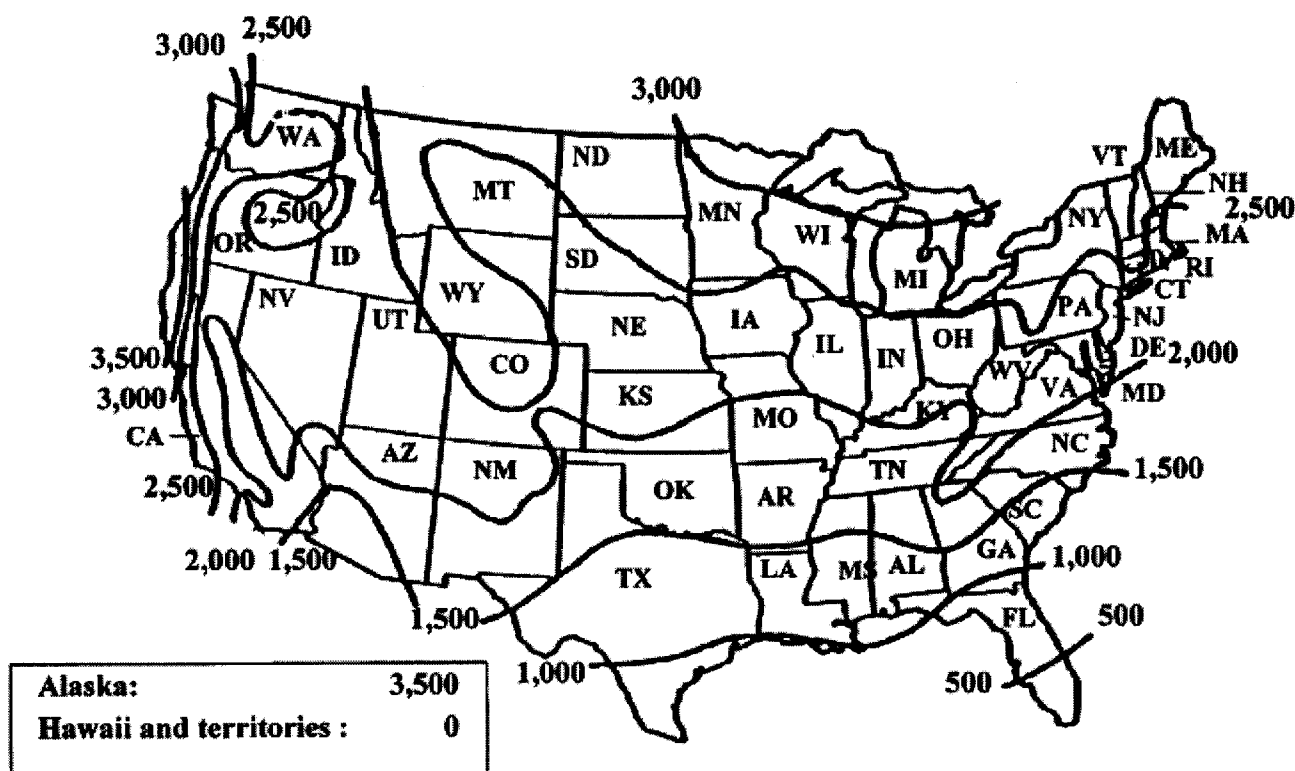
This map is reasonably accurate for most parts of the United States but is necessarily generalized, and consequently not too accurate in mountainous regions, particularly in the rockies.
