#### 1. All-Terrain Vehicles

An all-terrain vehicle (ATV) is a motorized vehicle with three or four broad, low-pressure tires (less than 10 pounds per square inch), a seat designed to be straddled by the operator, handlebars for steering, and designed for off-highway use. Since the 1980s, the CPSC has addressed ATV safety through various activities, including rulemaking, recalls, consumer education, media outreach, and litigation. These efforts focused on stability and handling issues related to ATV overturn and collisions. Figure 1 shows an example of an ATV.

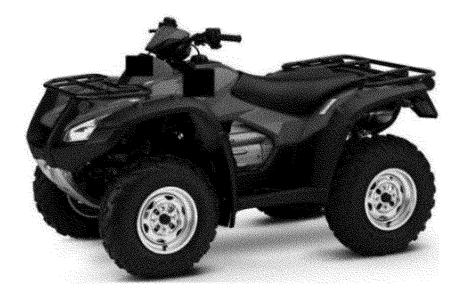
Figure 1: Example of an ATV

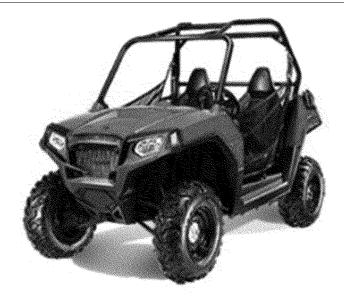
of a handle bar for steering; bench or bucket seats for the driver and passenger(s), instead of straddle seating; foot controls for throttle and braking, instead of levers located on the handle bar; and ROPS and restraint systems that are not present on ATVs. CPSC staff has worked on stability, handling, and occupant protection issues related to ROVs since 2009.<sup>2</sup> Figure 2 shows an example of an ROV.

Figure 2: Example of an ROV

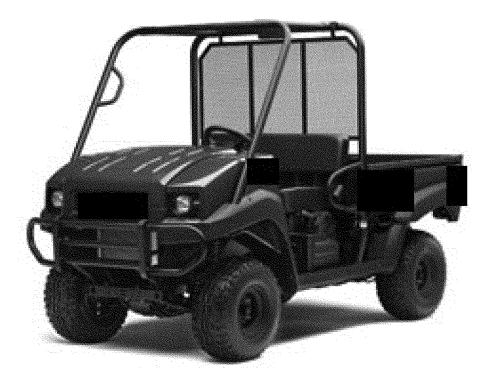
low-pressure tires designed for offhighway use with the same characteristics as ROVs (bench seating, steering wheel, foot controls, ROPS, and seat belts). However, UTVs are intended for utility use, have larger cargo beds to accommodate hauling-type tasks, and they generally have maximum speeds between 25 and 30 mph. Figure 3 shows an example of a UTV.

Figure 3: Example of a UTV

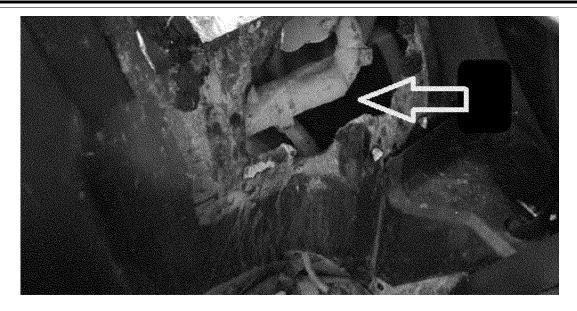
exhaust pipes and plastic paneling can cause the plastic to melt. Figure 8 illustrates a fire that ignited when melted plastic paneling dripped onto the exhaust pipe and burned a hole through the panel.

Figure 8 – Example of Fire Damage Caused by Excessive Exhaus Heat
